PROTIPS

Blue Print ADBP140015

Nissan Dualis 2007 > 2014, Note 1 2006 > 2013, Pathfinder 3 2005 > 2014, Qashqai 1 2006 > 2014

Clock Spring

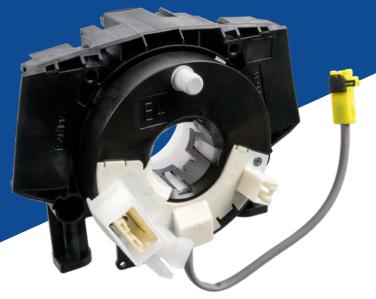
Clock Spring (Continued)

- To remove the steering wheel, take out the 19mm nut holding the steering wheel in place.
- Unscrew the three screws holding the shroud. Carefully 'part' the shroud, allowing access to the steering column.
- Remove the two multi-function switches by squeezing the top and bottom clips.
- Remove the two screws holding the clock spring to the steering column. You may need to release a wire clip at the top to fully release the unit and disconnect the electrical connectors from the back of the unit, with the grey connector disconnected first.
- Before fitting your new Blue Print ADBP140015 clock spring, you will need to transfer the steering-angle sensor (marked as 47945-JD000/JD00A) from the old clock spring. This is held in place by two screws.

- Firstly, reconnect the yellow electrical connector to the clock spring this interconnects with the grey one next to it.
- When the clock spring is attached to the steering column, remove the transportation lock.
- Refit the steering wheel, making sure that it is aligned correctly with the shaft. Feed the wires through the steering wheel.
- Tighten the steering wheel nut to 34 Nm.
- Refit the air bag unit.
- Reconnect the battery.
- Clear the fault code from the ECU and retest.
- To ensure that the correct level of resistance is maintained, it is advised that a small amount of dielectric grease is used on all electrical connections of the clock spring.
