Audi, Seat, Skoda, Volkswagen, Mitsubishi, various models

1.9 & 2.0 TDi Engines

Throttle Body

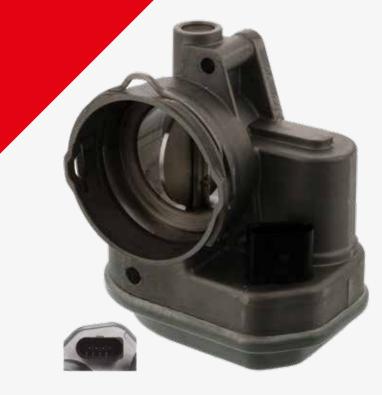
Engine management lamp illuminated, poor performance, increased engine temperature and/or engine shuddering during switch off. Fault codes logged relating to the throttle body, intake manifold flap and coolant fan motor.

The above symptoms can be caused by an excessive build-up of carbon deposits, failed throttle body drive components or a seized throttle plate. This results in a blown fuse which protects both the cooling fan and throttle body circuits.

Check and rectify all circuits relating to the faulty component and replace throttle body.
