febi 39304

various Citroen, DS, Fiat, Ford, Jaguar, Lancia, Land Rover, Mitsubishi, Opel, Peugeot, Toyota and Vauxhall models

Water pump with gasket

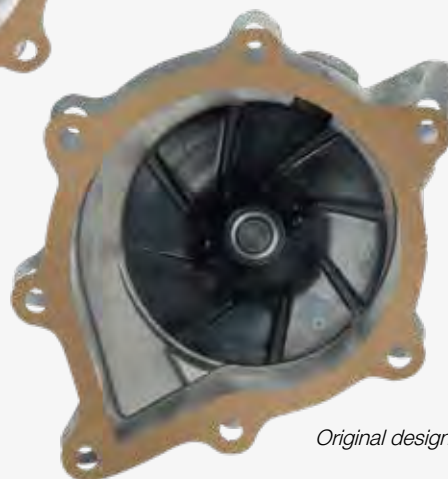
Original design

The original water pump impeller is made from plastic, which can become detached from the impeller shaft. Therefore, the water pump is turning with no effect and no coolant will flow around the cooling circuit of the engine.
