# febi 108778

**To Fit:** Various Volkswagen, Audi, Seat and Škoda models fitted with the 1.4 litre TDi engine.

## Water Pump with Sealing Ring

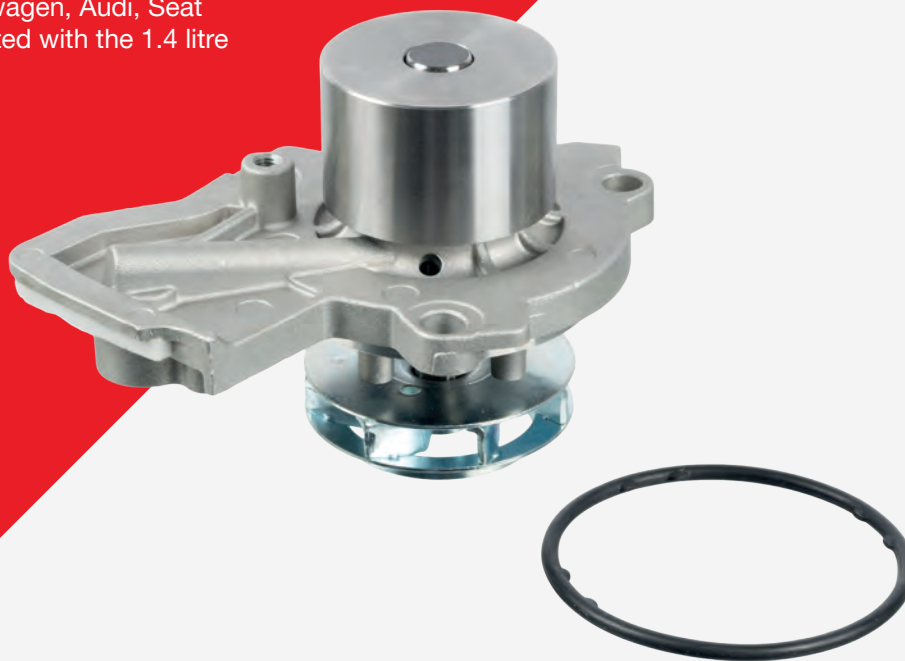
Engine overheating, coolant temperature gauge reading over 110° C and poor interior heater performance. Also cooling system fault codes maybe logged in the engine control unit.

The water pump fitted to these vehicles has an ECU controlled collar, which interrupts the coolant flow to make the engine more thermally efficient. However, the control collar can become seized, or the plastic impeller can break up or come away from the shaft.

Ensure the engine is cool, then remove the coolant filler cap. Remove the small pipe to the coolant header tank and hold this over the filler neck of the header tank, there should be a small trickle of coolant flowing with the engine at idle. This should increase in flow when the engine speed is increased. If the flow rate does not increase, this would suggest a faulty water pump.

Replace the defective water pump with febi 108778, this is a conventional water pump, which eliminates the potential failure caused by the control collar. The solenoid valve must be removed from the old pump and fitted to the new pump. This is so the engine management system can recognise it. Failure to replace the solenoid valve will log an engine management fault.

Fill the cooling system with the correct coolant, then vacuum bleed the cooling system. Finally carry out the cooling system bleeding procedure, using a suitable serial diagnostic tool, to expel all the air from the cooling system.
