Diagnosing a Wheel Bearing Fault on a Volkswagen Golf V

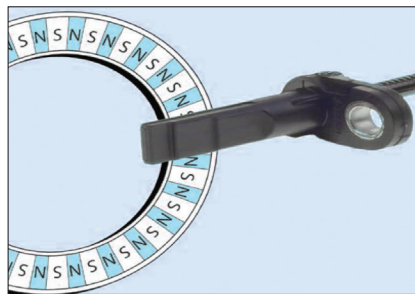
hub at right angles to the magnetised impulse retractor ring, which is mounted on the wheel bearing assembly. The active wheel speed sensor makes use of the magnetic resistive effect; a magnet in the sensor produces a magnetic field with the lines of magnetic flux running at right angles to the sensor layer. Deflection of the lines by the impulse wheel, causes changes in resistance in the thin ferromagnetic layer of the sensor element. (Fig.2) The sensor converts the

Fig 2. The sensor detects the rotating magnetic fields on the face of the bearing

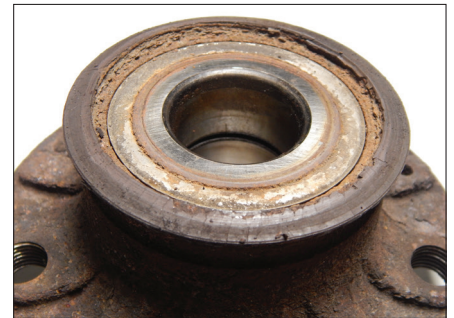
With the wheel bearing assembly removed from the stub axle, it became obvious what had been causing the issue. Corrosion between the ferrous metal of the wheel hub and the

magnetic retractor ring had caused distortion to the retractor, causing cracking of the magnetic ring and a narrowing of the air gap between the retractor and the wheel speed sensor. This was the primary fault with the vehicle. (Fig.3)

Fig 3. The retractor within the bearing was distorted, cracking the magnetic ring and was the source of the problem

febi wheel bearing kit (23320) was required as the replacement part. The wheel speed sensor (23810) was also replaced, because it had sustained some light damage from the distorted

retractor ring. The new bearing assembly and the wheel speed sensor were fitted to the car, along with the brakes and wheel.
