AUTOBIZ

TECH TIPS

7th Issue
April 2016

This 7th issue of Tech Tips has a roundup of all the Tech Tips that were published in Autobiz since June 2015.

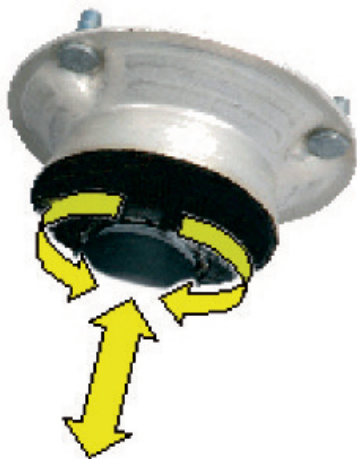
As a rebound stop, the strut top mounting limits the shock absorber's rebound path and must absorb substantial forces over a short distance. These parts wear until they fail completely due to the constantly changing stresses (Fig. 1) which increase due to poor road conditions. A strut top mounting should be checked every 12,000 miles and replaced every 60,000 miles.

Fig 1. Tension and compression movements have an impact on the strut top mounting

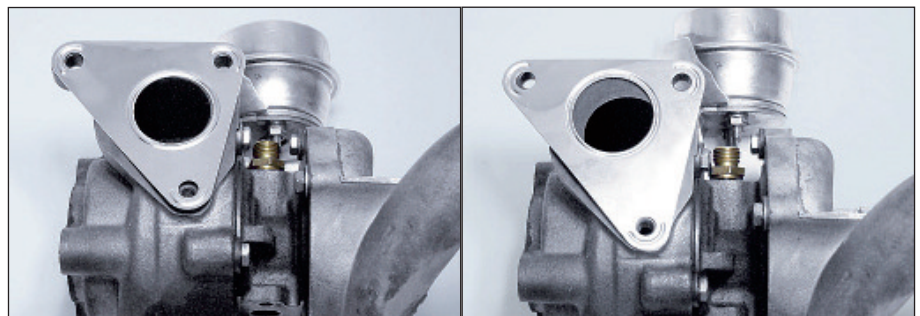
- A gasket inserted the wrong way around. This reduces the diameter and therefore also the flow rate, which can lead to whistling noises and/or a decrease in performance.
- Incorrect fit of the hoses/components of the charge air line. This can cause air to escape and as a result, whistling noises.
- Incorrect mounting of the housing. For certain types of turbochargers, the compressor housing is adjusted by loosening and tightening the mounting screws. If the screws are not tightened correctly, they can become loose during engine operation. The resulting angle of the housing causes the impeller to strike the housing, audible as "scratching" or whistling noises.

An incorrectly positioned gasket, at right, can cause a whistling noise and loss of performance

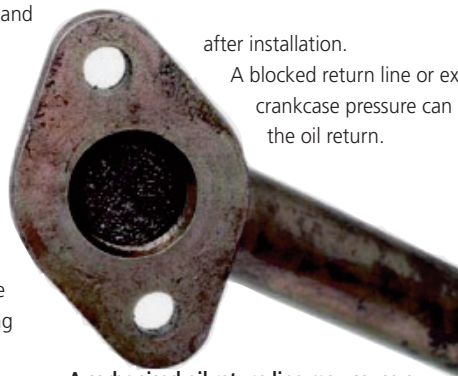
A carbonised oil return line may cause a replacement turbo to fail

Because the oil can no longer flow out into the oil sump after lubricating the bearings of the turbocharger, it accumulates in the bearing housing. At the same time, the oil pump supplies fresh oil to the bearing points for lubrication and cooling. The oil must now somehow flow out of the bearing. However, since the return flow is blocked due to the clogged line, it searches for another path: despite the sealing piston rings, it is forced into the compressor and turbine side where it is carbonised, or is burnt in the combustion chambers via the intake air and the exhaust system via the turbine.

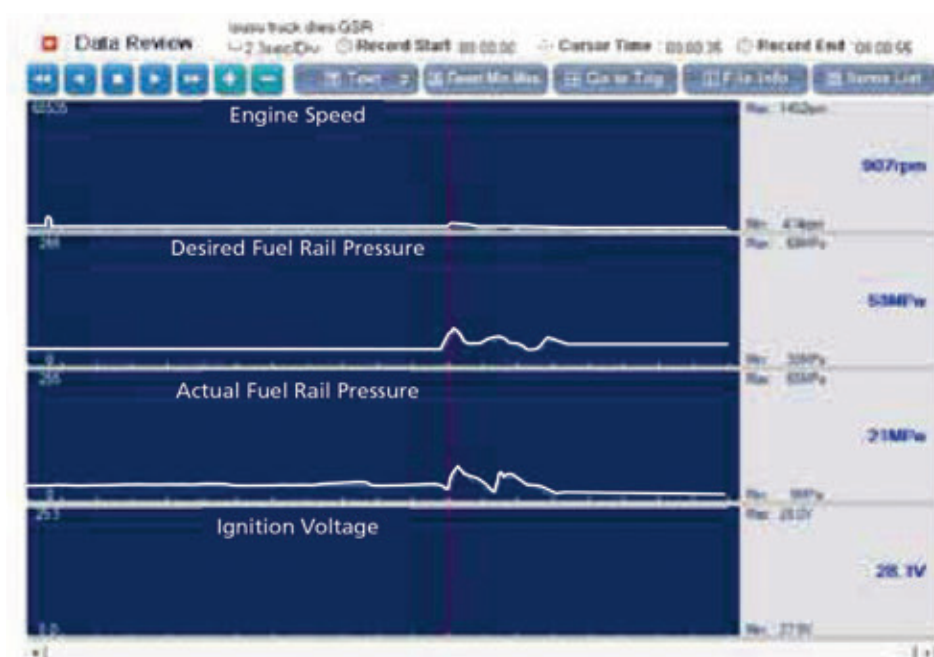
Figure 1 - Discrepancies between desired and actual fuel rail pressures provided the first clue to solving the problem.

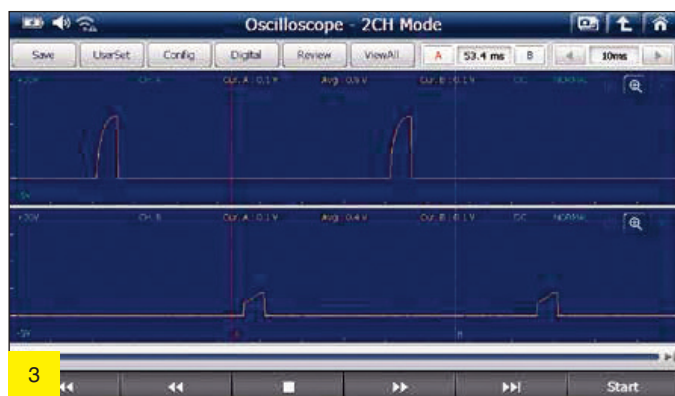
The coil pulse to cylinders 1 and 4, on top, had a higher voltage, as well as a different shape

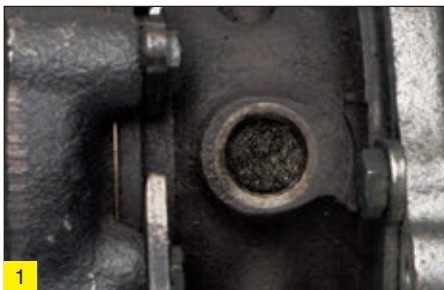
If oil carbon enters the bearing case, (Fig. 1) it can result in any or all of the following: blue smoke, loss of engine performance, loss of engine oil, contamination of the charge-air cooler, clogged exhaust gas cleaning system and with adjustable turbochargers, blocked control mechanisms.

Generally, these effects are caused by poor quality engine oil, an overheating turbo or the immediate shut down of a hot engine. Therefore it is vital to use the correct grade of oil as specified by the vehicle manufacturer (VM) and to let a hot engine run for at least a minute before shutting it down.

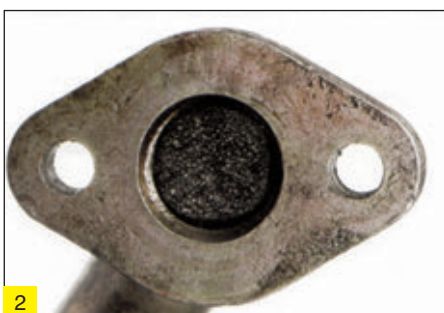
Oil carbon deposits in the oil pipe (Fig. 2) can have similar effects to oil carbon in the bearing case, but can also lead to excessive turbocharger noise, and even total turbocharger failure.

Additional causes include an overdue oil change, incorrectly installed oil pipe or a missing heat shield. Subsequent additional remedies include replacing the oil pipe and ensuring its correct installation and replacing the charge-air cooler and particulate filter if the turbocharger has been replaced.

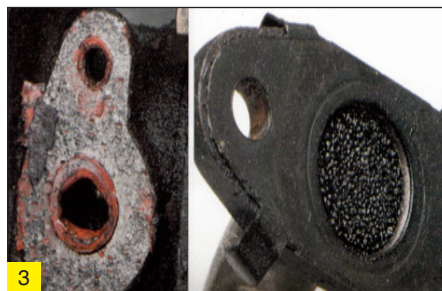
Excessive oil consumption can often be due to a problem with the oil return pipe (Fig. 3), which in common to the aforementioned oil related issues, means that oil can be forced into the turbine and the compressor, which can affect the operation of the internal components and can collect in the charge-air cooler.

Probable causes include constriction or a bend in the oil return pipe, the use of sealing compound rather than a gasket set, the failure to replace the engine connection when replacing the return pipe, or even simply too much oil in the engine.

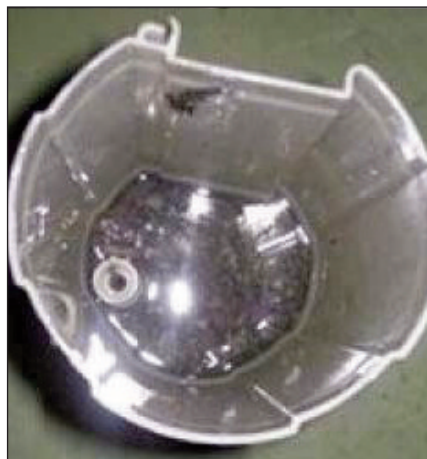
Paint sludge inside the fuel pump assembly

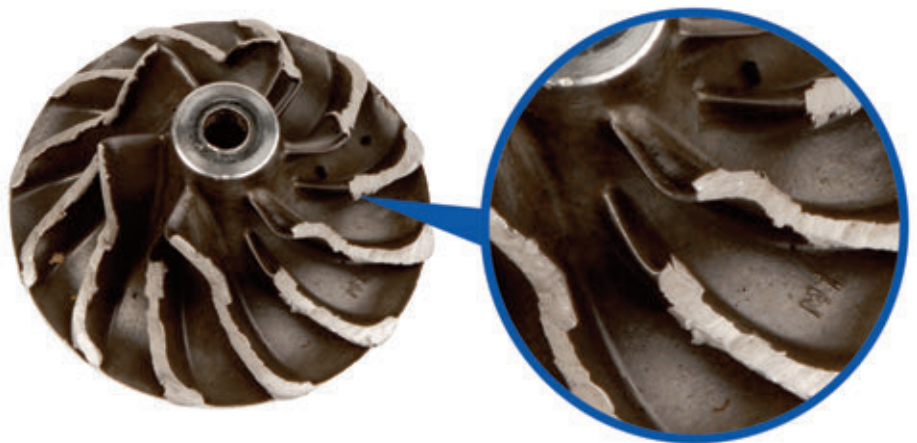
During overspeeding, the inducer can grow in size and rub against the housing

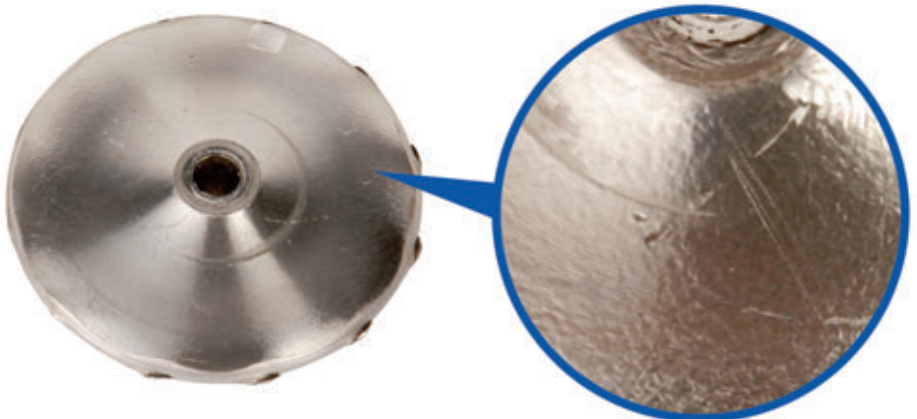
Orange peel on the back of the inducer is another sign of overspeeding
