BMW X3 - Electronic EGR valve installation

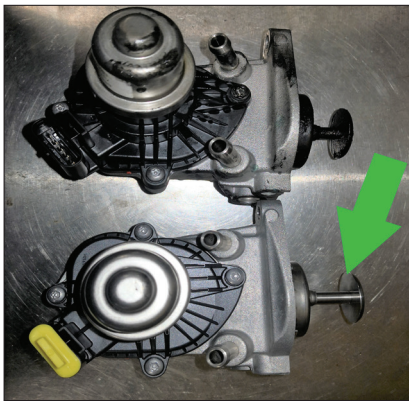
It is important that the valve is powered into the energised position to prevent contact when fitting

When the replacement EGR Valve arrived, it came with a red warning on the box, indicating that special measures should be taken. These measures are important, and the valve needs to be connected up and powered into the energised position, using diagnostic equipment before fitting. If these measures are not taken, then force may be applied to the valve head during installation, causing damage to the internal drive gears.
