Hot start issues on a VW T6 Transporter with a CXGA engine

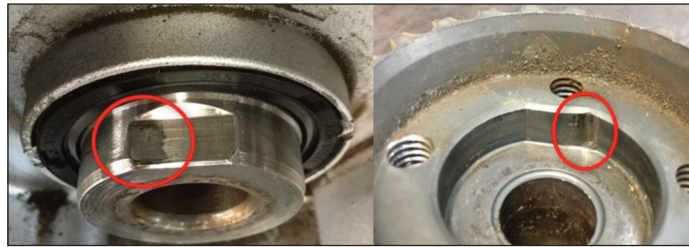
Damage on the crankshaft sprocket caused the timing misalignment

When replacing a timing belt on these engines, it is advisable to remove the crankshaft sprocket and inspect the timing belt to confirm a timing issue, no misalignment was present.

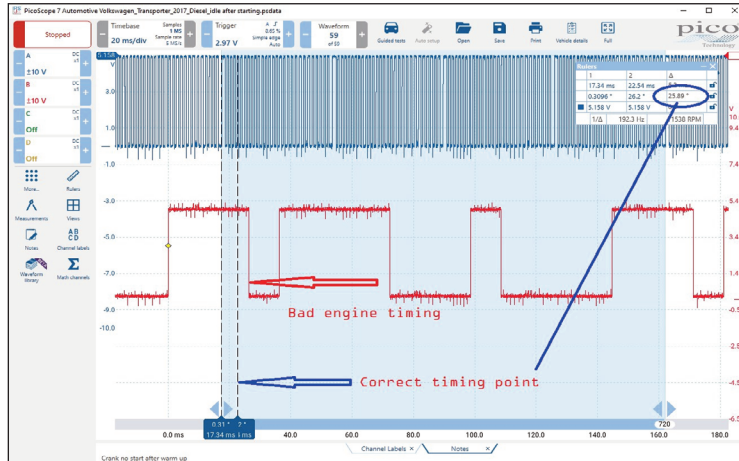
The scope trace showed there was a timing misalignment problem

A scope analysis of the cam and crank signals was performed, and the trace was compared to a known good signal for this engine code. We could see the issue was a timing misalignment. A deeper investigation was required, even though the timing marks and tools fitted correctly.
