AUTOBIZ
TECH TIPS

7th Issue
April 2016

TECH TIPS

This 7th issue of Tech Tips has a roundup of all the Tech Tips that were published in Autobiz since June 2015.

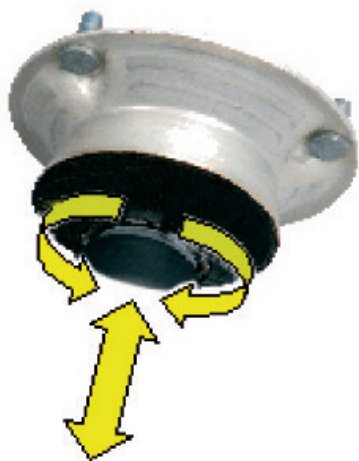
As a rebound stop, the strut top mounting limits the shock absorber's rebound path and must absorb substantial forces over a short distance. These parts wear until they fail completely due to the constantly changing stresses (Fig. 1) which increase due to poor road conditions. A strut top mounting should be checked every 12,000 miles and replaced every 60,000 miles.

Fig 1. Tension and compression movements have an impact on the strut top mounting

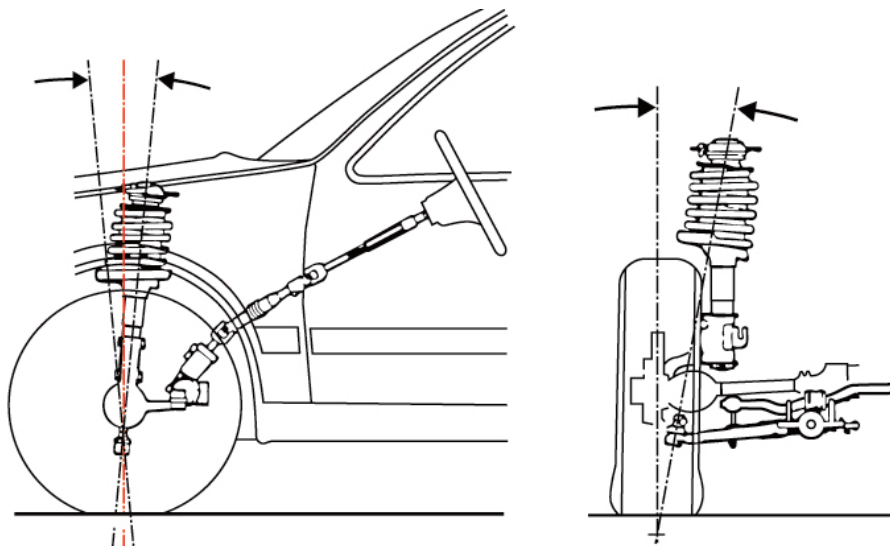
Fig 2. The effect of the strut top mounting on axle geometry

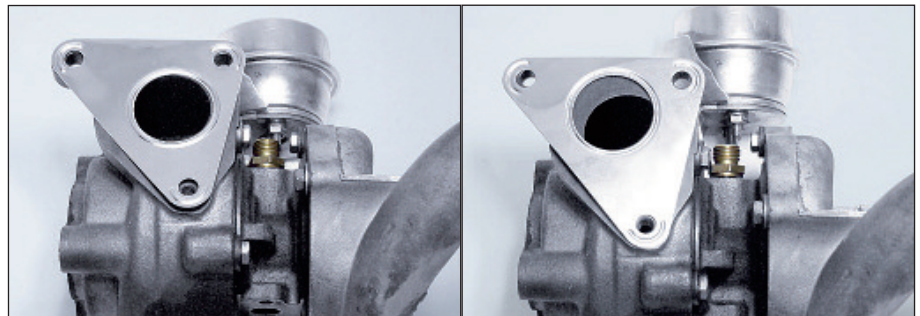
- A gasket inserted the wrong way around. This reduces the diameter and therefore also the flow rate, which can lead to whistling noises and/or a decrease in performance.
- Incorrect fit of the hoses/components of the charge air line. This can cause air to escape and as a result, whistling noises.
- Incorrect mounting of the housing. For certain types of turbochargers, the compressor housing is adjusted by loosening and tightening the mounting screws. If the screws are not tightened correctly, they can become loose during engine operation. The resulting angle of the housing causes the impeller to strike the housing, audible as "scratching" or whistling noises.

An incorrectly positioned gasket, at right, can cause a whistling noise and loss of performance

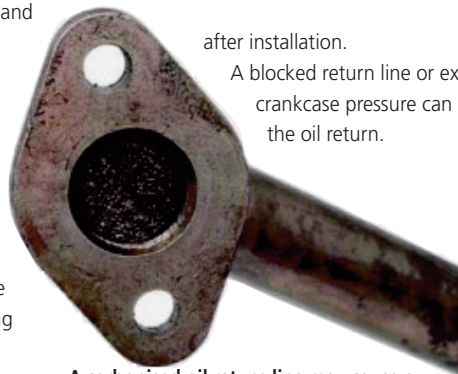
A carbonised oil return line may cause a replacement turbo to fail

Because the oil can no longer flow out into the oil sump after lubricating the bearings of the turbocharger, it accumulates in the bearing housing. At the same time, the oil pump supplies fresh oil to the bearing points for lubrication and cooling. The oil must now somehow flow out of the bearing. However, since the return flow is blocked due to the clogged line, it searches for another path: despite the sealing piston rings, it is forced into the compressor and turbine side where it is carbonised, or is burnt in the combustion chambers via the intake air and the exhaust system via the turbine.

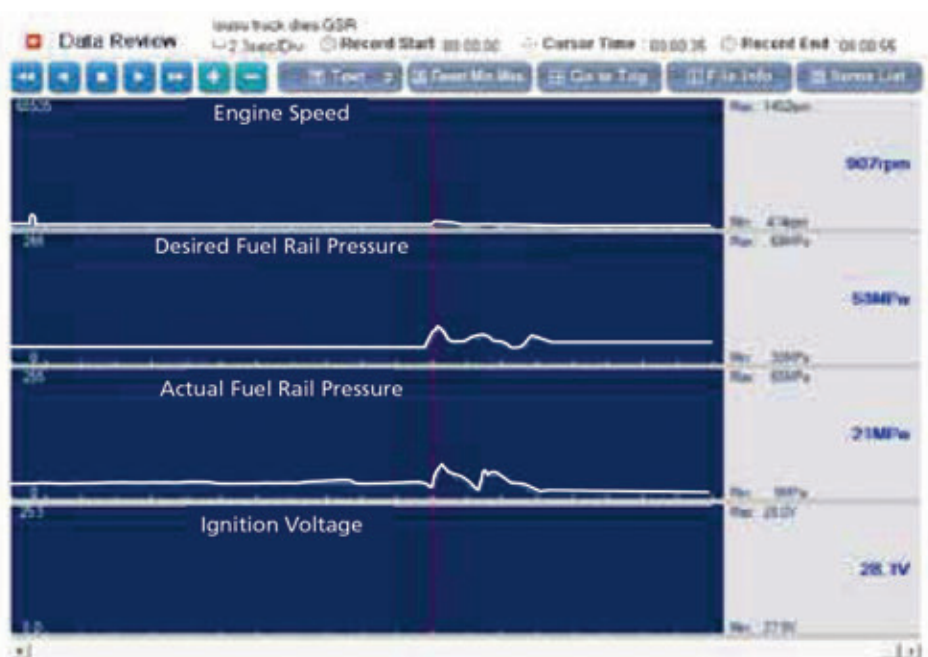
Figure 1 - Discrepancies between desired and actual fuel rail pressures provided the first clue to solving the problem.

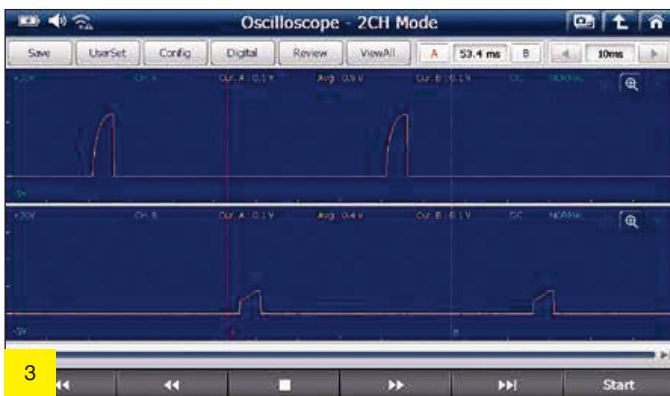
One advantage of having two separate coils is that you have one to compare against. First, I separated the connector for inspection; it was very clean and had no corrosion to cause a high resistance. I then used a break-out lead to save using back probes. I checked both the coils supply voltage and grounds under operating conditions - both were good. Then I checked the ECU trigger pulse and compared the signal for both coils. The pulse to the coil for cylinders 1 and 4 had a different pattern and a

The coil pulse to cylinders 1 and 4, on top, had a higher voltage, as well as a different shape

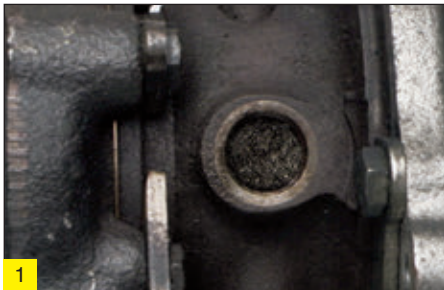
If oil carbon enters the bearing case, (Fig. 1) it can result in any or all of the following: blue smoke, loss of engine performance, loss of engine oil, contamination of the charge-air cooler, clogged exhaust gas cleaning system and with adjustable turbochargers, blocked control mechanisms.

Generally, these effects are caused by poor quality engine oil, an overheating turbo or the immediate shut down of a hot engine. Therefore it is vital to use the correct grade of oil as specified by the vehicle manufacturer (VM) and to let a hot engine run for at least a minute before shutting it down.

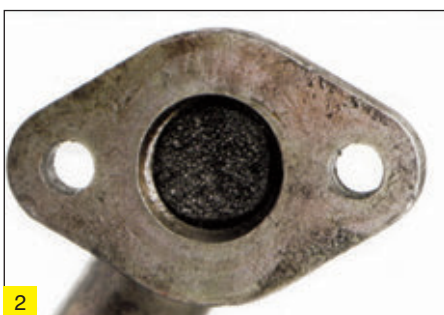
Oil carbon deposits in the oil pipe (Fig. 2) can have similar effects to oil carbon in the bearing case, but can also lead to excessive turbocharger noise, and even total turbocharger failure.

Additional causes include an overdue oil change, incorrectly installed oil pipe or a missing heat shield. Subsequent additional remedies include replacing the oil pipe and ensuring its correct installation and replacing the charge-air cooler and particulate filter if the turbocharger has been replaced.

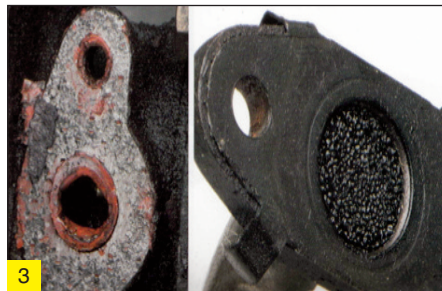
Excessive oil consumption can often be due to a problem with the oil return pipe (Fig. 3), which in common to the aforementioned oil related issues, means that oil can be forced into the turbine and the compressor, which can affect the operation of the internal components and can collect in the charge-air cooler.

Probable causes include constriction or a bend in the oil return pipe, the use of sealing compound rather than a gasket set, the failure to replace the engine connection when replacing the return pipe, or even simply too much oil in the engine.

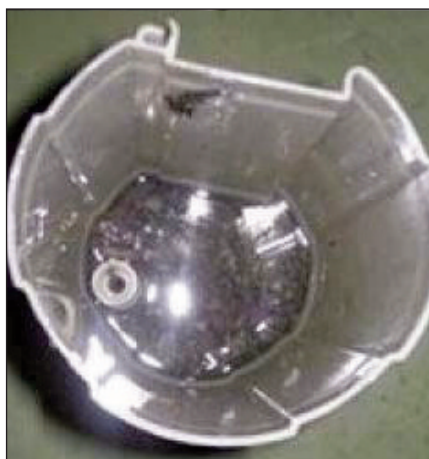
Paint sludge inside the fuel pump assembly

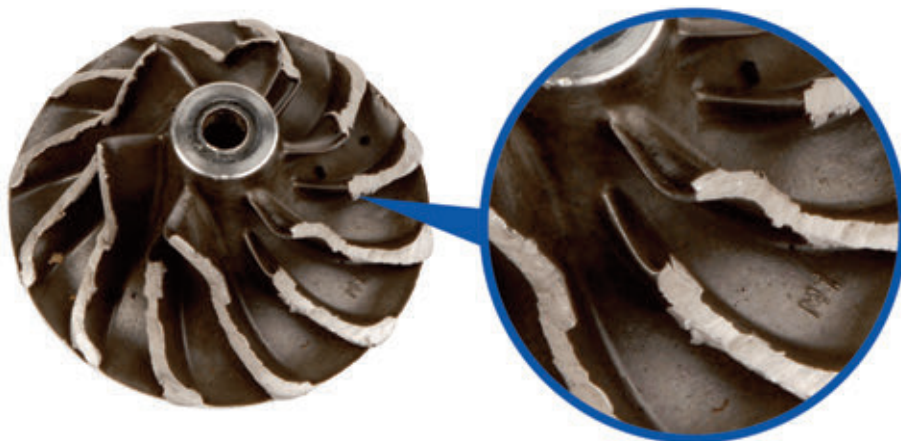
During overspeeding, the inducer can grow in size and rub against the housing

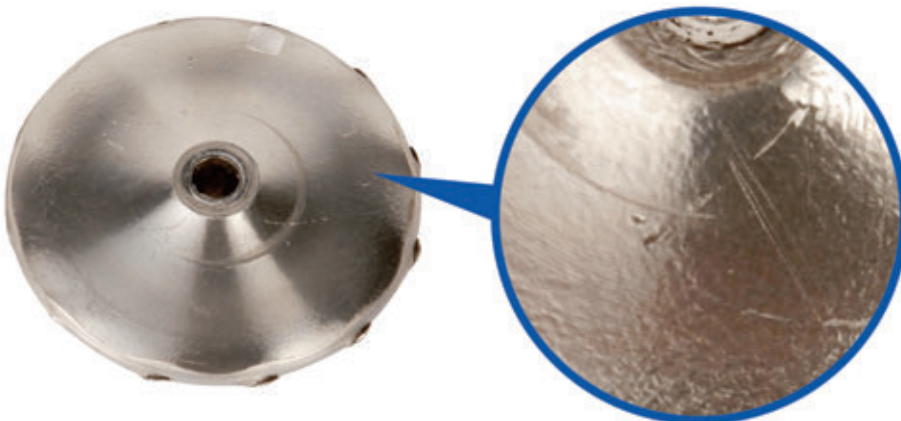
Orange peel on the back of the inducer is another sign of overspeeding
