AUTOBIZ

*TECH TIPS*

2nd Issue  
Dec 2011

## Welcome to the second edition of the Autobiz Tech Tips Supplement

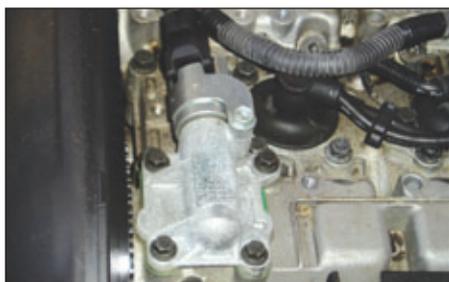
On closer inspection of the actuator, significant amounts of solidified engine oil deposits could be seen in the galleries within the actuator. These deposits were cleaned out with a degreasing agent, and the problem was resolved.

**A build-up of oil deposits had intermittently interfered with the variable valve timing**

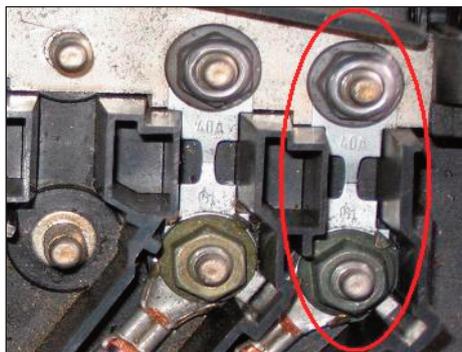
You probably remember that some of this vehicle's fuses are housed within the plastic battery cover and these fuses are just thin metal strips between two bolt fixings. A blown fuse can be seen very clearly, but in our case, the fuse had actually cracked and looked more like a scratch than a defective fuse. The fuse was replaced and the ABS was completely functional again.

**A crack in a strip fuse, circled, can cause an intermittent fault. An observant eye will also suspect that the other strip fuse in this example needs to be replaced as well.**

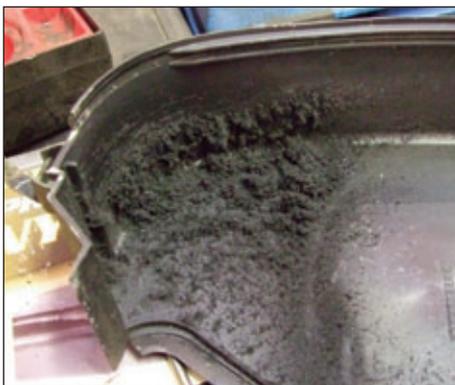
Evidence from the broken belt is often the key to the correct diagnosis. Whenever a camshaft stops turning - as this one had - the usual suspect is the timing belt. Closer inspection showed that it was not a problem with the main drive. The smaller secondary belt had failed. Careful examination of the pieces showed that the belt had been significantly reduced in width.

It had been 'worn away' on the edge closest to the engine block, with the result that the narrower belt had been unable to sustain the load. The belt had snapped, allowing piston-valve contact that destroyed the engine.

Debris from the worn belt was abundant inside the drive system cover

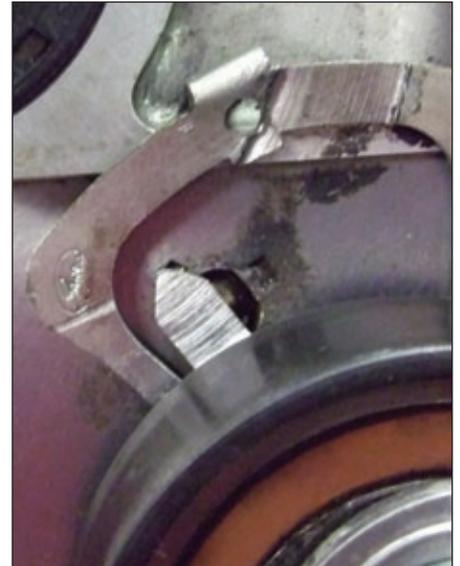
As part of good engineering practice, the VW Golf had had a drive system overhaul, which involves replacement of belts and tensioners. In replacing the automatic tensioner however, a mechanic had installed it upside down, initiating the following sequence of events:

- small drive belt makes contact with backplate of tensioner
- contact begins to 'pare away' the edge of the belt
- width of the belt gradually reduced
- stress increases until the belt snaps
- piston to valve contact
- destruction of the engine

The upside down tensioner left no clearance room for the timing belt, as can be seen by the scoring in this picture

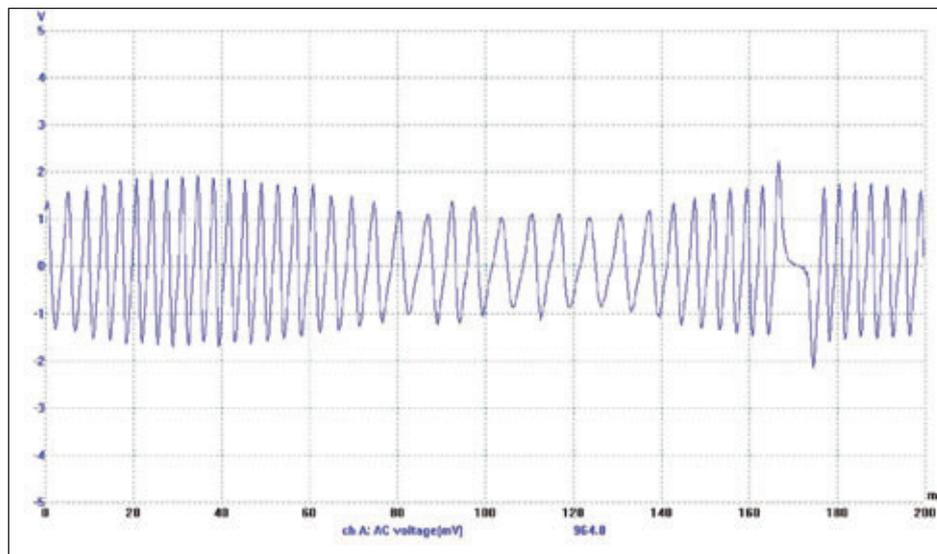
On further investigation, it became clear that although the engines were nearly identical, they had one main difference - the flywheel. If the engine had been used in conjunction with its original gearbox, then this problem would never have arisen. But they had used it with the vehicle's original gearbox, which had a slightly different fixing/profile for the crankshaft position sensor. This resulted in the sensor being just under 2 mm further away from the flywheel, resulting in the erratic RPM reading and scope trace.

The scope trace of the crankshaft sensor signal showed it was too low, as well as erratic.

The solution to this problem was to exchange the flywheels. As you can see from this, more diligence and understanding of your diagnostic readings is paramount for modern common-rail diesel engines.

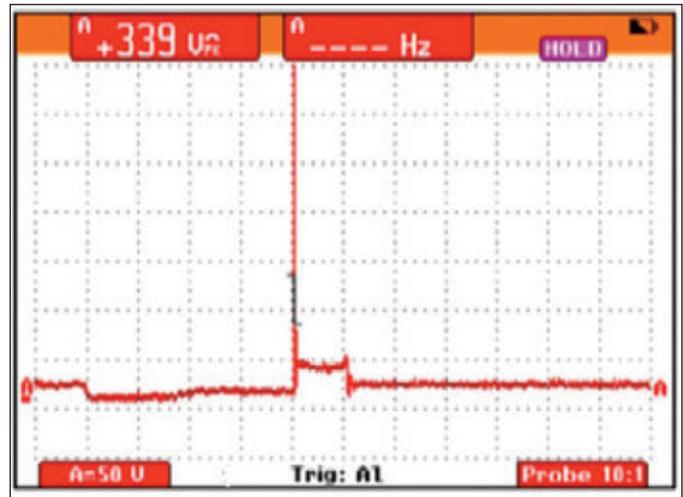
there is no current limiting hump. In fact, 2 ms into the coil charging time, the engine ECM stopped charging this coil, or what was more likely happening was that the insulation on this coil was breaking down. The breakdown of the coil insulation created an earth path, and prevented this one coil from charging properly. Also note that the burn time was only half the time of the other two coils, and that there are no coil oscillations indicating a very discharged coil. The faulty coil was replaced, the code was cleared and the emissions returned to normal.

Figure 2. One of the coils in the Mercedes was obviously faulty, the result of a short to earth through the coil insulation.

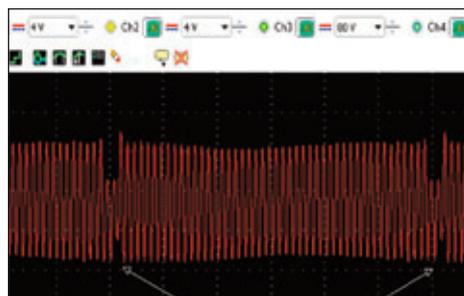
The oscilloscope trace showed two strange anomalies in the signal. Since these anomalies appear in a fixed pattern, it could not have been an electronic fault, so it was mechanical. The repetition was caused by particular teeth on the ABS disk teeth when they passed in front of the sensor. The signal also showed a slight amplitude variation. This is not uncommon, and is caused by the fact that the ABS disk is not perfectly round. When the disk was examined the problem was obvious, some of the teeth on the sensor wheel were physically damaged.

Figure 2: The sensor signal at higher speeds showed an obvious fault, at arrows

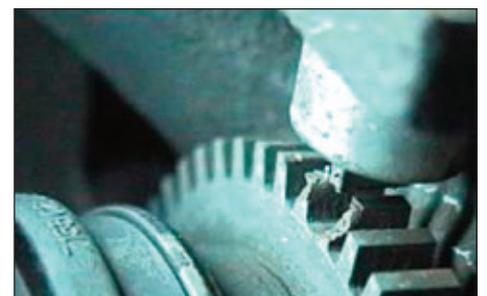
The only question that remained was why the fault was only reported by the ECU at speeds above 110 kph. The scope trace of the wheel speed sensor signal at 110kph showed that the signal amplitude dropped when the broken teeth passed the sensor was even greater than at low speeds. At low speed, the peak to peak amplitude when the broken teeth passed the sensor was 1.5 Volts. At 110 kph the voltage dropped to below 1.0 volt and was great enough for the ECU to recognise the fault. The ABS ECM sets a limit on the voltage of the signal coming from the ABS wheel sensors. This can be a fixed value, where the signal always must be above or under a defined value, but it is also possible that a limit is set dynamically and depends on the speed of the car. So it can be that at a lower speeds, the limits are less strict then at a high speed.

Figure 3: Defective teeth on the ABS disk were good enough for lower speeds
