Timing belt teeth issues

Teeth can be sheared off the timing belt during initial start-up after belt replacement, or after a short mileage after replacement. When this problem occurs on the following Euro 6 diesel engine Makes/Models: Opel 2.0; Citroen/ Peugeot 2.0/ 2.2 Blue HDi; Ford 2.0 TDCi / ECONetic / ECOBlue; Toyota 2.0 D4D, this Continental TechTip will help you find and prevent this problem from occurring.

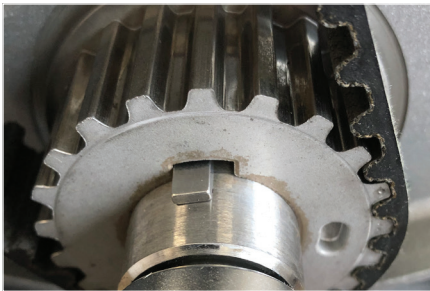
The belt drive is equipped with an oval crankshaft sprocket to reduce power peaks in the belt drive. The crankshaft sprocket is mounted loosely, and can be twisted on the shaft without using the special tool. This, in combination with an incorrectly mounted high-pressure pump, leads to greatly increased force peaks and can cause the timing belt to fail.

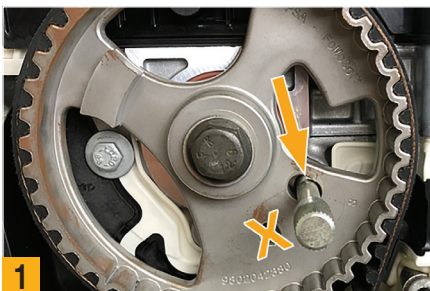
The camshaft sprocket has two locking points: 8mm (Fig. 1) > 1st cylinder TDC for changing the timing belt
6mm (Fig. 2) > approx. 75° further, for disassembly/assembly of the injection pump.

When working on the high-pressure pump beforehand, it is essential to ensure the correct installation position!

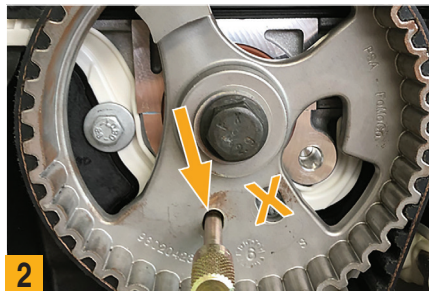
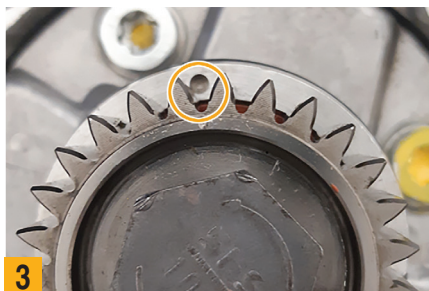
The high-pressure pump itself has markings on the pinion as well as on the housing (Fig. 3), which must be aligned for correct installation. If the high-pressure fuel pump was removed and installed in addition to the timing belt change, first install the timing belt completely and then the high-pressure pump

The difficulty is finding the markings. Used pumps are sometimes wetted with black oil on the gear wheel and the special features of this pump are simply not known to many workshops. A sticker on the injection pump indicates that the special installation instructions must be observed.

If the high-pressure fuel pump was removed and installed in addition to the timing belt replacement, it is essential to ensure the correct installation sequence! First fit the timing belt completely and then the high-pressure pump. The tensioning process must be carried out according to the vehicle manufacturer's instructions, using all the special tools intended for this purpose.
