VW Golf - Clutch release bearing failure

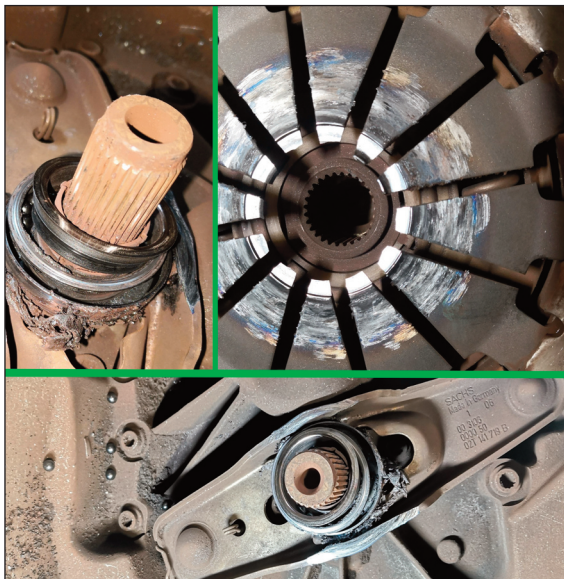
With this particular vehicle, it was not the clutch plate which had worn down excessively

The cover and release bearing were damaged

causing clutch problems, but the release bearing which had failed. This resulted in a not only a poor feel to the pedal, but a screaming coming from the failing release bearing in the gearbox.

Fortunately, the owner had the sense to get the clutch changed before any further damage occurred.
