## Air flow error but **air intake is OK**

2018 Vauxhall Astra was brought Lto our garage. Kennedy's Garage. Portlaw, Waterford, with an unusual complaint. The Astra had been serviced at another garage a few days before the owner was heading off on a holiday. When he collected the car after the service, he thought that the car was not running normally and it seemed to be a little bit off. The next day when he was driving, the check engine light came on. He was heading to Dublin airport the next day for a holiday, but on his way thee, the Astra lost power. The recovery truck took him to the airport, and then took the car back to Waterford.

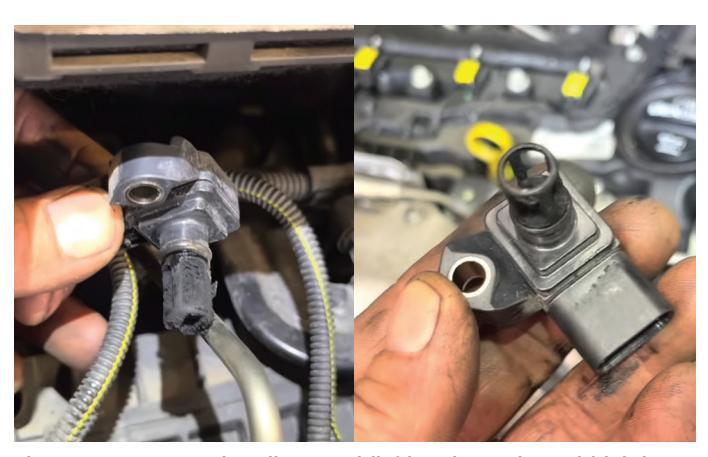
The MAP sensor was heavily sooted (left) and was cleaned (right)

I then examined the manifold absolute pressure (MAP) sensor to see what it looked like. On removal, I could see it was heavily soiled with carbon, but not to the point where I thought it would have made a significant difference. I cleaned the MAP sensor and reinstalled it, but there was no difference in the live data readings from the mass airflow sensor.

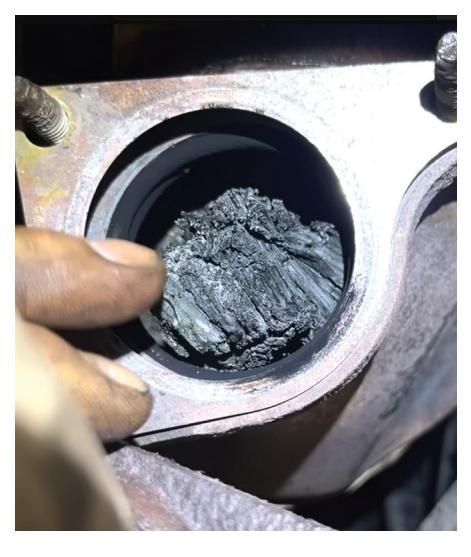
## The matrix of the PDF had failed and was partially plugging the exhaust

I disconnected the exhaust pipe flange just downstream from the DPF. Once the exhaust pipe was moved, a clear view into the DPF was possible and the problem was very obvious. A large portion of the matrix material of the DPF had broken away, and was partially clogging the exhaust as it transitions from the DPF to the remaining portions of the exhaust system.

The exact cause of the failure of the DPF was not determined. That will be the work for another day. Whether it was a faulty injector (one had been recently replaced), or possibly excess oil in the sump compromising the DPF was not clear. What was clear was that the DPF had failed and was the cause of the mass airflow readings.
