Capillary Action - Sucking up fluids where they don't belong

Case Study 1: BMW Mini Cooper with multiple fault issues

Case Study 2: 2010 Citroen C3 with multiple fault issues

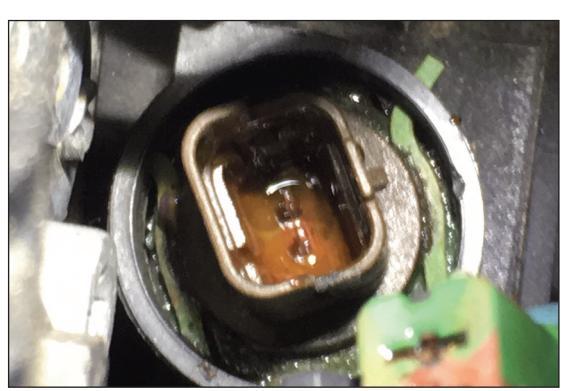
When disconnecting the coolant sensor for resistance testing, it was discovered that coolant was leaking into the connector plug, an obvious mechanical failure of the sensor.

The coolant sensor on this Mini had failed and was leaking

Cleaning the contamination, drying the ECM connector and replacing the coolant temperature sensor, and opening up the loom and drying the affected cables, cured all the issues.

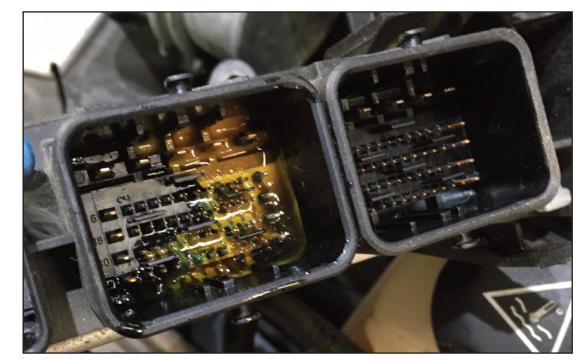
The Lambda sensor was inspected, and no fault found with the component, so the ECM was unplugged, to circuit test the wiring to the lambda sensor. This is when we found coolant had wicked up the loom from the coolant temperature sensor and contaminated multiple terminals in one ECM multiplug.

The leaked coolant wicked up to the ECM and was causing multiple problems

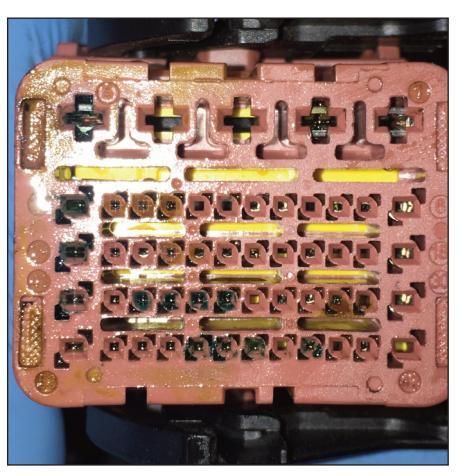
Fluid wicking up a wiring loom caused damage within this connector

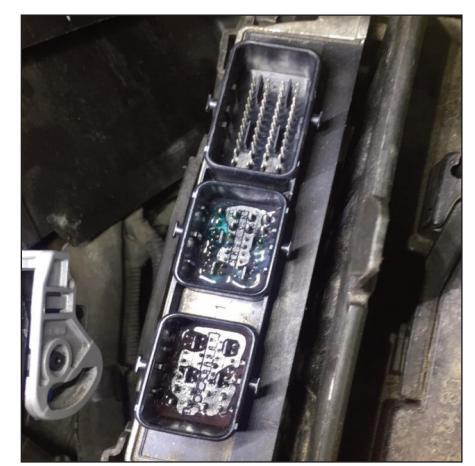
Coolant had wicked up a wiring loom and caused this damage at the ECM
