# Citroen Cactus - Oil Filter Access

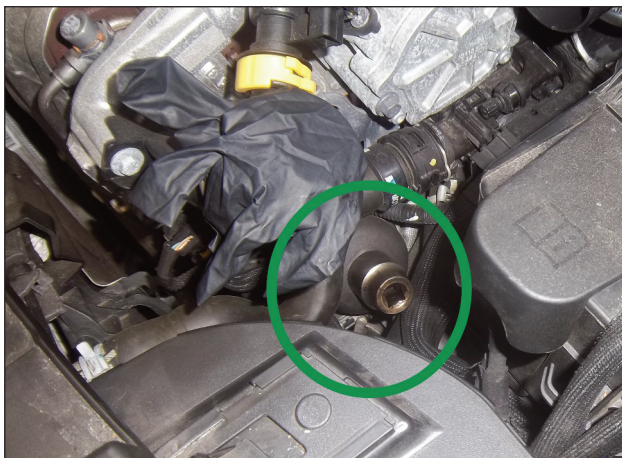
This 2015 Citroen Cactus 1.6 Diesel deserves a mention for the awkwardness of access to the oil filter. Sitting low down on the nearside of the engine, it is hidden by the turbo and air induction pipes. These pipes are both plastic, and I feel that after too many removal and fitting operations, will begin to lose their shape. I

My other worry is that when removing the turbo induction pipe, to access the oil filter housing, this then leaves a gaping hole straight

**Access to the housing first requires the induction hoses to be removed, note we have covered the opening to the turbo with a glove for safety**

into the turbo. For safety sake, and to prevent the worry of something unwanted dropping into the exposed turbo, we always cover the opening as soon as the hose is removed.

Because the drain plug is built into the oil filter, fitting the new filter requires the element to be located in the base of the housing before the top can then be fitted. Caution is required due to the position to ensure the cap thread is correctly located before tightening the housing down.
