Discovery ABS Sensor Problem

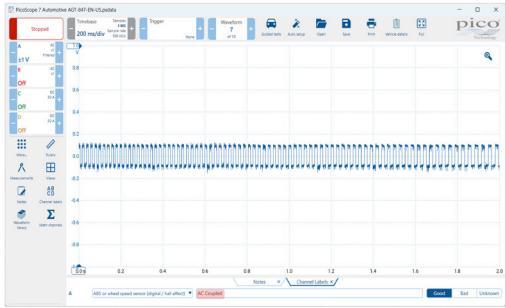
With a scope set to "AC Coupled", the signal will be evident on the 12V side of the sensor connector polarity of the connection. Both sensors gave the same resistance values, so we swapped the new OE sensor to the good side loom connection. To our surprise, the fault migrated to that side, so there was an issue with the sensor.

A typical MRE signal will only be around 300mV. With a scope set to "AC Coupled", the signal will be evident on the 12V side of the sensor connector.
