## 3 System failures from 1 Actual fault

## Case Study - Peugeot 207 1.4 2008 KFU

## Range Rover/Jaguar MAF issues

## Case Study - 2009 Discovery 4 3.0 TDV6

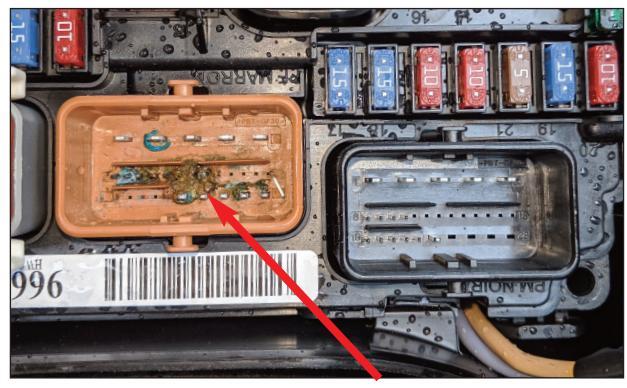
Corrosion in the relay connector caused a short circuit and faults

Further investigation revealed the root cause of all the issues: Water damage to the switching protection unit. A replacement

switching unit was fitted and the multiplug was repaired. No further issues reported and all faults were cleared.

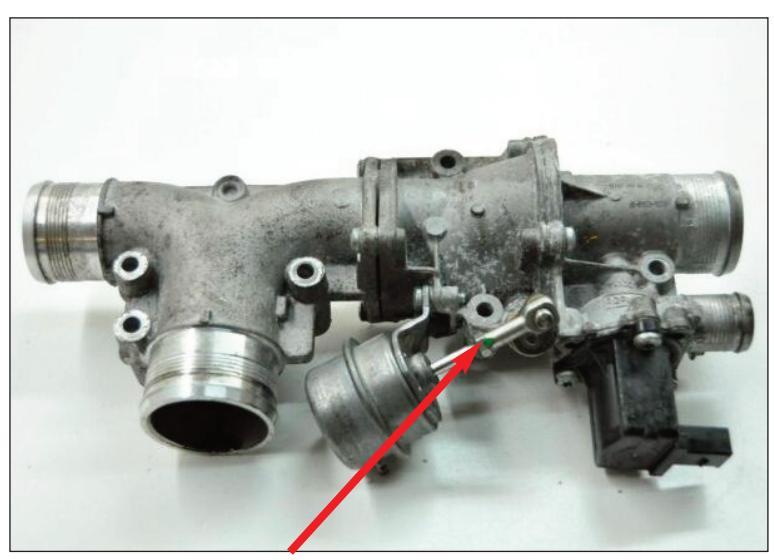
On investigation, it was found that the right hand turbocharger has a boost bypass valve that only comes into play when additional power is demanded. When driven at low power settings, this valve does not get regularly utilised. As a consequence, it has a tendency to get stuck. Freeing of the control rod cured this issue.

The bypass control rod (at arrow) gets stuck on the right turbocharger chasing a low MAF reading from one of the sensors, wrongly thinking that both turbos spool up at the same rate.
