Tim Stock

Alternators - Time for a rethink

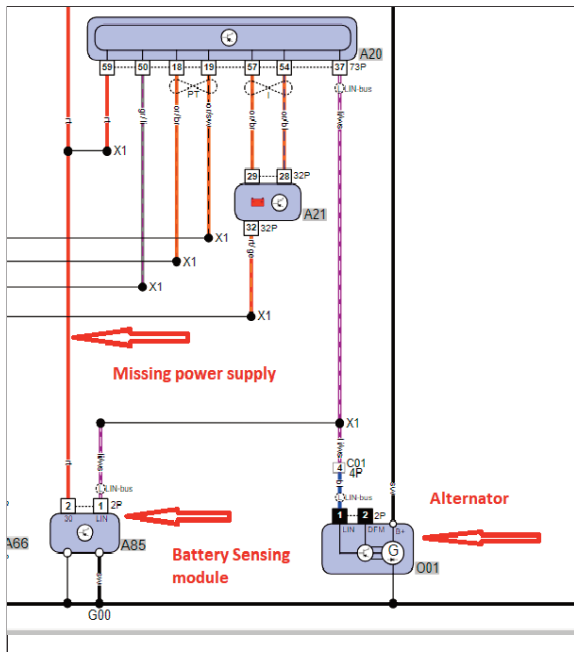
A missing power supply to the battery sensing module caused an incorrect voltage supply to the alternator

A recent vehicle issue we had was with a 2013 Skoda Fabia II 1.2 TDi CFWA engine, with a fault logged for over-voltage in the central electronics module. On testing the charge rate, the workshop found 14 volts in all modules serial data and at the battery, obviously not over-charging the technician thought. The technician who was very experienced in diagnostics, contacted me for advice on how to approach this issue, as they had not seen it before.

As the vehicle was fitted with Stop Start and a battery monitoring module, we decided to scan all systems and found the central electronics module measuring block 002 was expecting 12.8 volts as the desired output, but was getting 14.0 volts from the alternator.

A LIN check on the battery monitoring module, showed that the module had lost a power supply from a 5 Amp fuse next to the battery. After a little investigation, a broken wire was found, 6 inches from the battery, that was coming from the supply fuse. After repairing the wire and clearing the faults, the charge rate was now 12.8 volts and the data for desired charge rate was the same 12.8 volts.

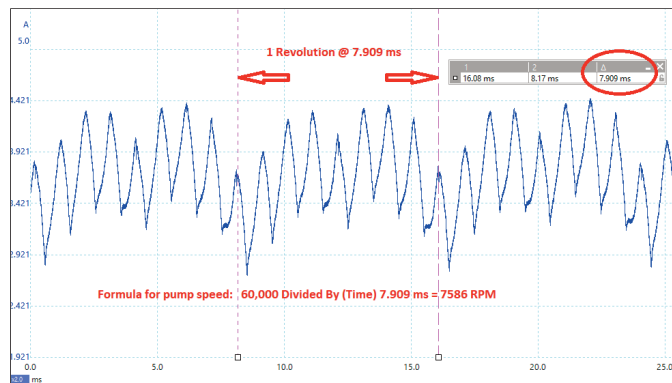
I gave them some information on how to test the fuel pump performance with the scope, using some time measurements and a mathematics formula. Most electric fuel pumps run at around 5000 rpm when pumping fuel under pressure. Using a formula you can check this. They found that the pump was drawing

Current draw by the fuel pump was used to calculate its speed

lower than expected current, and was also running too fast, at around 7500 rpm. This proved that the pump was the problem.
