## **BMW ABS issue**

Tech Bits

## BMW 1 Series E87 Case Study

## Nissan Micra K12 Case Study

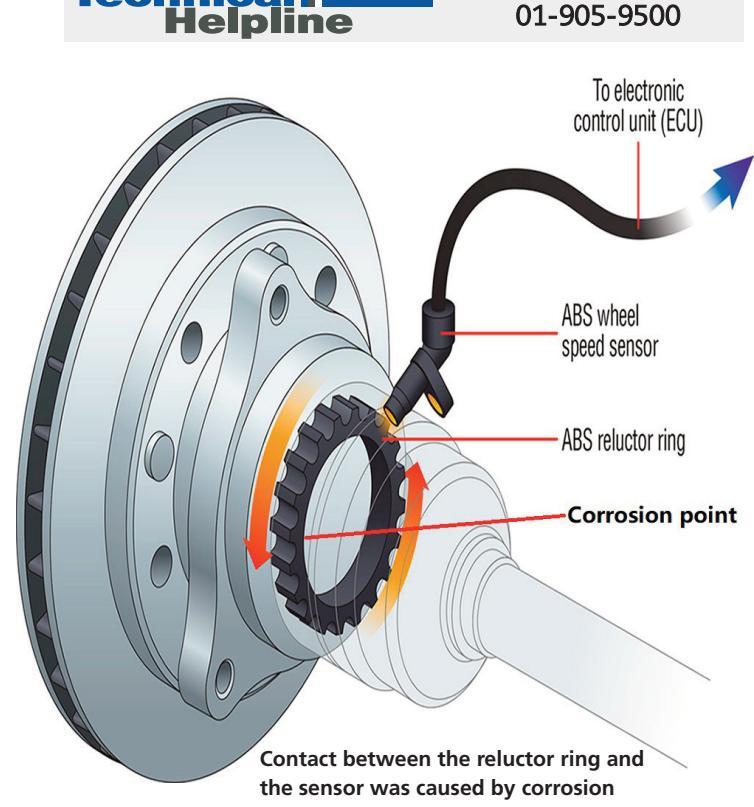
Drilling down deeper into the fault, the reluctor was inspected very closely. Two of the teeth on the ring looked much cleaner than the rest. On close inspection of the failed sensor, very slight scratch marks were visible on the tip

The reluctor was measured and all teeth where compared to each other in height. It was found that 2 teeth were raised very slightly, and had been contacting the tip of the sensor.

The reluctor had been subject to corrosion between the reluctor and the driveshaft, altering the air gap very slightly. The contact between the raised teeth and the sensor had damaged the sensing element.

After repairing the drive shaft and reluctor, the fault was cleared and did not occur again.

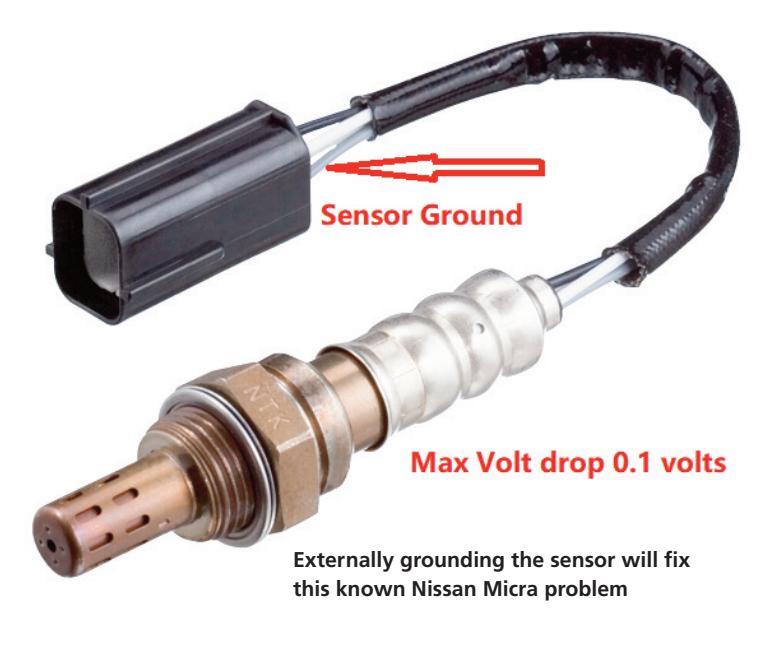
It was then the Helpline was called to assist with the diagnosis and repair. We asked for the lambda sensor signal to be tested with a scope. In doing this, we found that the signal was switching in the low range 0.1 volts to 0.45 volts.

Then we asked for the sensor ground to be scoped, and this is when we found 0.25 volts present on the O2 sensor earth. Testing the sensor earth at the ECM multiplug still showed the high voltage drop on the earth return line.

This is a known problem for the Nissan K12 Micra and an internal issue within the ECM is the root cause.

However, a fix has been found. Externally grounding the Lambda sensor loom rectifies the issue, and allows the Lambda signal to return to the correct level. With this fix, the emissions settles back to the correct levels and the idle improves.
