## **Intermittent Faults**

#### Case Study: 2008 Hyundai Santa Fe 2.2 CRDi

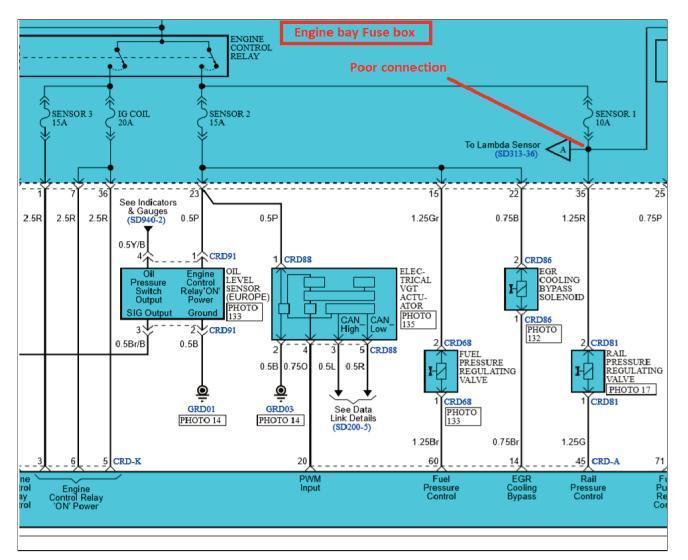
A poor electrical connection had caused the intermittent fault

So, we decided to monitor the rail pressure signal, the rail pressure control solenoid signal, the control solenoid current, and solenoid supply voltage. Over the next few days, the signals where monitored every time the vehicle was started from cold, and on the fourth day the problem occurred. On play back of the scope trace when the fault occurred, the current was lower on the control solenoid and supply voltage dropped to 3.3 volts, indicating an issue. The supply voltage returned to battery voltage after cycling the key. We investigated the wiring diagram for the circuit and found a splice that was responsible for the intermittent low voltage issue. The connection was

not firm and at times would be not fully connected, resulting in a voltage drop at the connection. The loom was corrected to prevent any further volt drop problems and the intermittent problem has not returned.
