Toyota Multi-Mode transmission (MMT) clutch replacement

<u>Tech Bits</u>

Volkswagen/Audi oil warning light remaining on at all times

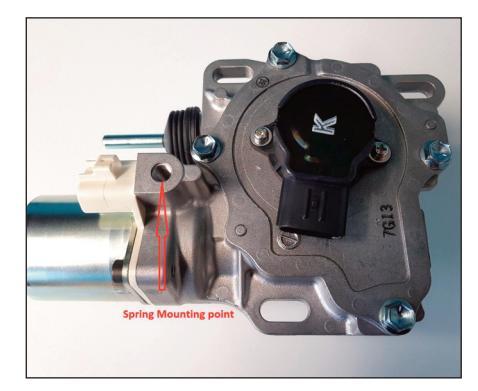
Location of the calibrated spring in the slave assembly

After refitting the gearbox, and trying to select a gear, the N on the display will be flashing and no gear will be selected.

try the manual method of bridging connectors in the DLC. But these methods often fail, due to the free play in the clutch mechanism. After some research, we found a method that will allow the transmission to continue with the basic initialization procedure.

Toyota have available a calibrated spring to overcome this problem. When fitted to the 2 mounting holes, one in the slave assembly and the other in the cylinder head to preload the slave assembly, the configuration can be completed as normal.

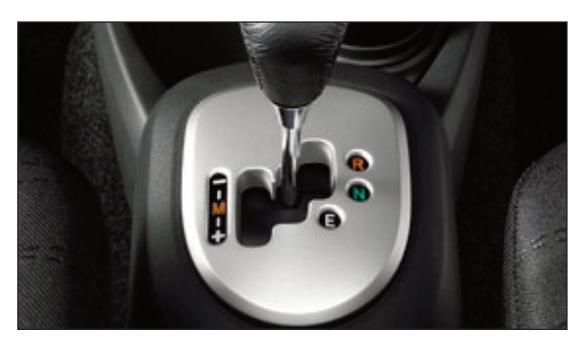
It may look like an automatic gearbox, but it isn't

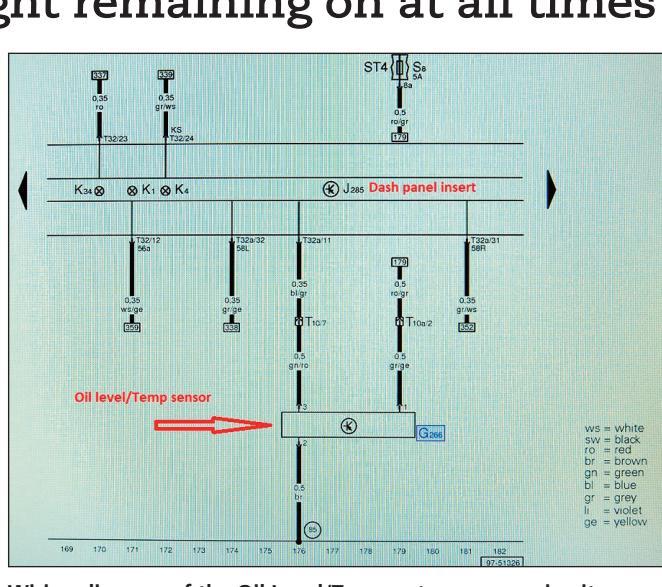
A circuit check on the oil level sensor revealed no faults. The power supply was load tested, as was the ground. The signal line to the cluster also passed a load test. But the warning light remained on. So, a new Oil Level /Temperature sensor component G266 was fitted. Still, the warning light remained on.

Wiring diagram of the Oil Level/Temperature sensor circuit

failed and was not working. So, if the bonnet switch status is not showing the bonnet opened or closed, the oil warning light will not reset.
