**BERU**

# SPARK PLUG TROUBLE TRACER CHART

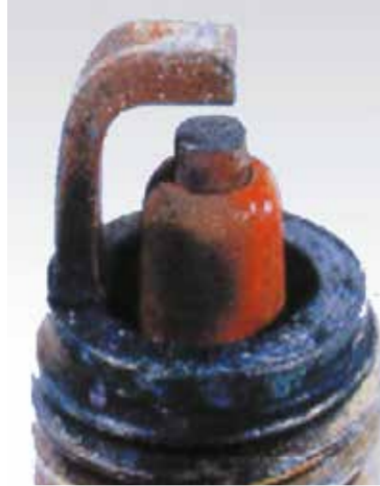
## Fuel Additives

- **Appearance:** Reddish/brown or purple deposits/coloration on the core nose insulator
- **Cause:** Use of fuel additives
- **Effect:** Misfire. Normally additives are non-conductive; however, some are and if the deposit build up is excessive it can create an earth leakage path for the spark
- **Remedy:** Replace spark plugs and ensure that any additives used are compatible with the engine manufacturer's ignition and emission systems and added in the correct proportion

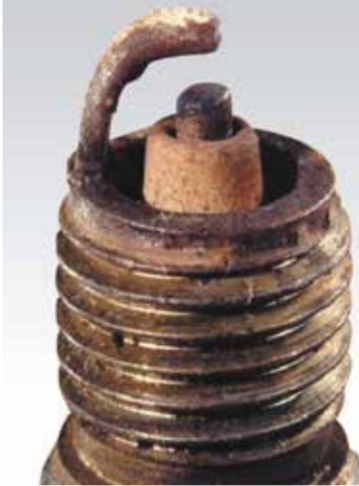
## Worn-out Spark Plug

- **Appearance:** Centre and/or ground electrodes are rounded and the gap is excessive
- **Cause:** General wear (spark plug has come to the end of its life). However, the greyish tan/white colour indicates that the plug is the correct heat range and also that the fuel/ignition systems and engine are generally in good condition
- **Effect:** An increased gap will multiply the workload on the ignition system and may cause misfire, poor fuel economy, and damage to other ignition components.
- **Remedy:** Replacement is recommended with new plug of the same heat range

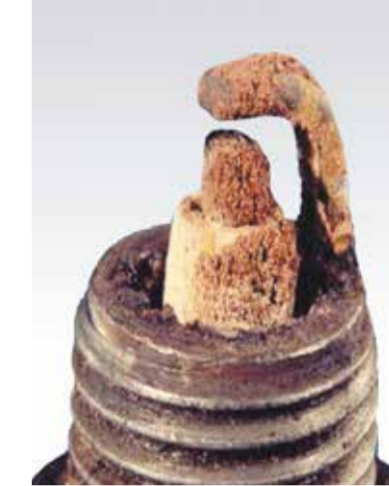
## Ash Deposits

- **Appearance:** Light brown deposits encrusted on the centre and/or ground electrode
- **Cause:** Often due to excessive fuel (or oil) additives, however, general engine wear can have a similar effect on the spark plug
- **Effect:** Ash deposits can 'shield' the spark, leading to misfire problems
- **Remedy:** Ensure plug is of the proper heat range and check for engine wear

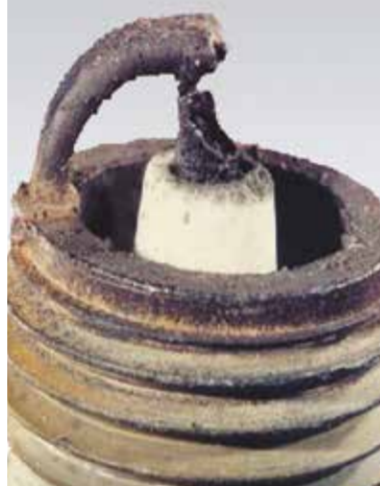
## Pre-ignition

- **Appearance:** Melting (or partial melting) of the ground and/or central electrode
- **Cause:** Spark plug too hot, air fuel mixture excessively lean, incorrect ignition advance, defective exhaust re-circulation system, faulty detonation sensor, cross induction in the spark plug leads or worn engine components
- **Effect:** In extreme cases engine damage will result
- **Remedy:** Identify the cause and rectify. Replace spark plugs in line with manufacturer's recommendation

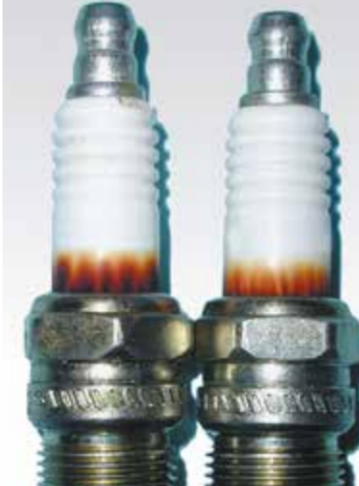
## Corona Discharge Stain

- **Appearance:** Discoloration of the ceramic insulator, near to the shell
- **Cause:** Particles of oil/gas (in the spark plug well), becoming attracted to the ceramic by the magnetic field created by the high voltage current flowing through the spark plug
- **Effect:** Not detrimental to spark plug operation
- **Remedy:** Ensure that spark plug "well" is clean when installing new spark plugs

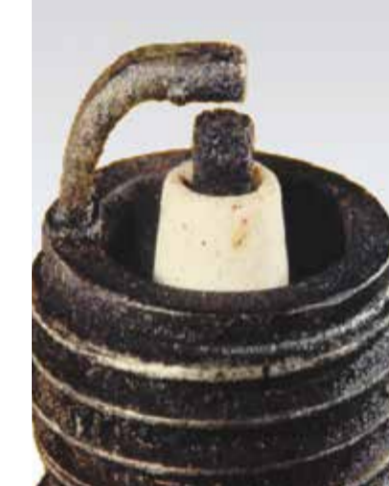
## Overheating

- **Appearance:** Chalky white insulator (with no tan colouring) pitted or blistered electrodes. In some cases the insulator will begin to turn grey or dark blue
- **Cause:** Improper heat range plug, lean air fuel mixture, incorrect ignition timing, insufficient plug tightening torque and general engine overheating
- **Effect:** General poor running conditions
- **Remedy:** Identify the cause of overheating and rectify. Replace spark plugs in line with manufacturer's recommended heat range

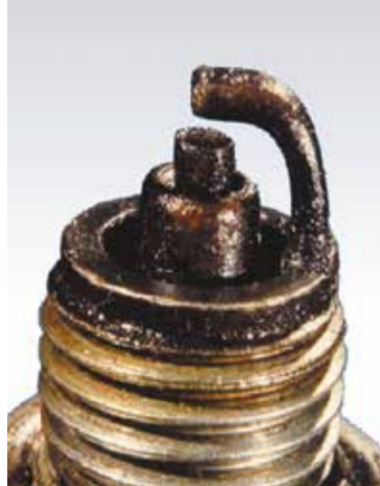
## Oil Fouling

- **Appearance:** Firing end of spark plug is 'wet' with lubricating oil
- **Cause:** Usually a sign of advanced engine wear (excessive volumes of oil in the combustion chamber), oil fouling can also be caused by a fault in the crankcase breather system
- **Effect:** Misfire due to oil deposits covering the firing end of the plug preventing the spark from 'jumping the gap'
- **Remedy:** Rectify the cause of excessive oil in the combustion chamber and replace spark plugs

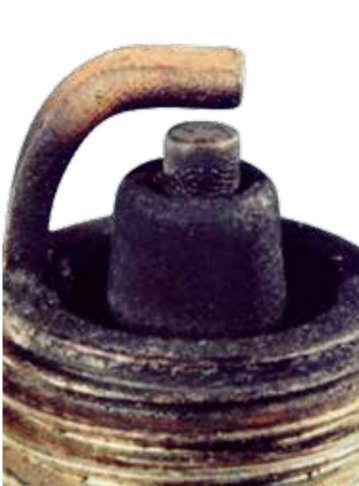
## Cold/Carbon Fouling

- **Appearance:** Soft, black, sooty deposits on the firing end of the plug
- **Cause:** Rich air-fuel mixture, weak ignition, spark plug too cold or repetitive short journeys
- **Effect:** Carbon deposits are conductive and can create earth leakage paths, often resulting in misfire problems which can lead to catalyst damage
- **Remedy:** Check fuel & ignition systems, general engine performance and driving style before plug replacement. Confirm that the spark plug (part number) is correct for the application

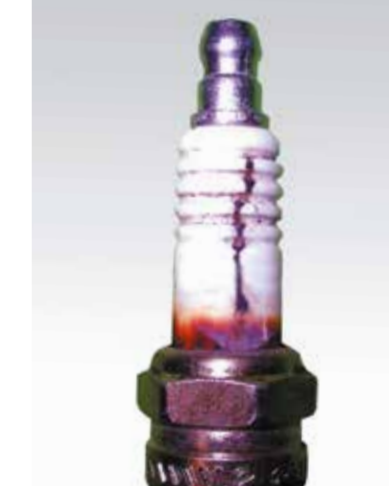
## Flash Over

- **Appearance:** Black burn marks (carbon tracks) running vertically down the spark plug insulator towards the shell
- **Cause:** Current discharge from the top terminal of the spark plug, down the outside of the insulator to earth; due to poor fitting/worn spark plug boot
- **Effect:** Engine misfire
- **Remedy:** Replace the affected plug(s) and plug lead(s)

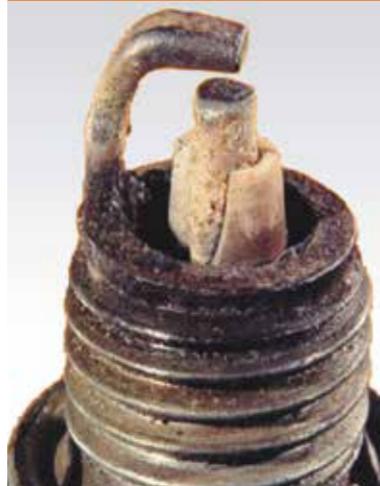
## Detonation

- **Appearance:** Light detonation will cause black/grey spots on the insulator or ground electrode. Severe detonation can crack or even break the insulator or ground electrode
- **Cause:** Abnormal combustion, causing pressure spikes/shock waves in the combustion chamber. Can result from: inoperative exhaust gas re-circulation system, defective detonation sensor, lean air fuel mix, incorrect fuel octane rating or spark advance and loose fitted spark plugs
- **Effect:** Misfire and/or general poor/uneven running which may result in engine damage
- **Remedy:** Identify the cause and replace the spark plugs

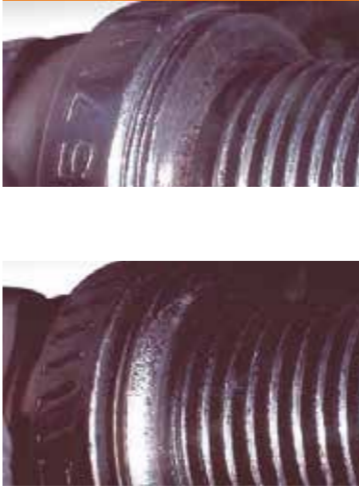
## Spark Plug Tightening

- **Appearance:** Spark plug gasket has not been sufficiently crushed (see photographs)
- **Cause:** Incorrect tightening of the spark plug
- **Effect:** If the plug is too loose, correct heat dissipation will be prevented, resulting in overheating of the plug which can lead to pre-ignition or detonation problems. Conversely, if the plug is too tight, damage may result to the insulator and internal components causing operating problems
- **Remedy:** Tighten spark plugs to the manufacturer's recommended torque value

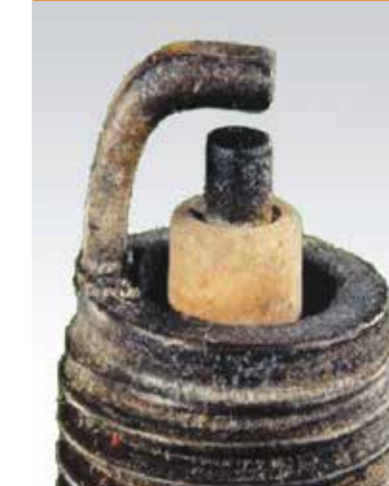
## Normal Spark Plug Wear/Operation

- **Appearance:** Greyish tan to white colour around the insulator, at the firing end
- **Cause:** Confirms that the spark plug is the appropriate heat range and has been firing correctly. Also indicates that the fuel and ignition systems are working efficiently and the engine is mechanically sound
- **Remedy:** None required other than to check the spark plug gap and replace in line with manufacturer's recommendations
