## Technical Bulletin

Product Focus –Idle Speed Control Valve (Stepper Motor) ADC47430 Mitsubishi FTO 2.0 & Galant 2.5 V6 models Date Issued: 01/02/2007

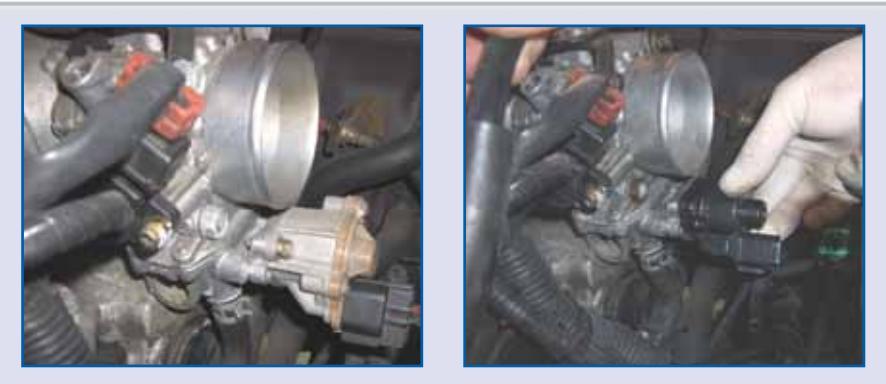
It is our experience that the Idle Speed Control Valve (Stepper Motor) commonly fails on the Imported Mitsubishi FTO 2.0 and UK Galant 2.5 V6 models.

Symptoms will include stalling, 'hunting' or erratic idle speeds (especially from cold). These symptoms may be intermittent in the early stages of failure, but it is highly likely that the problem will become worse or fail completely.

The unit is mounted in the throttle body assembly, and will require the air box cover and ducting to be removed to gain access. Please note that the original 'O' ring should be re-used or replaced when removing the valve (not supplied with new unit). It may be possible to confirm diagnosis without the Mitsubishi harness tool by removing and cleaning the valve (may temporarily remedy problem), or by checking the Stepper Value on the live data function of a diagnostic scanner. The value should be approximately 50-70 under normal operation; however a unit tested by Blue Print with a known fault displayed 114.

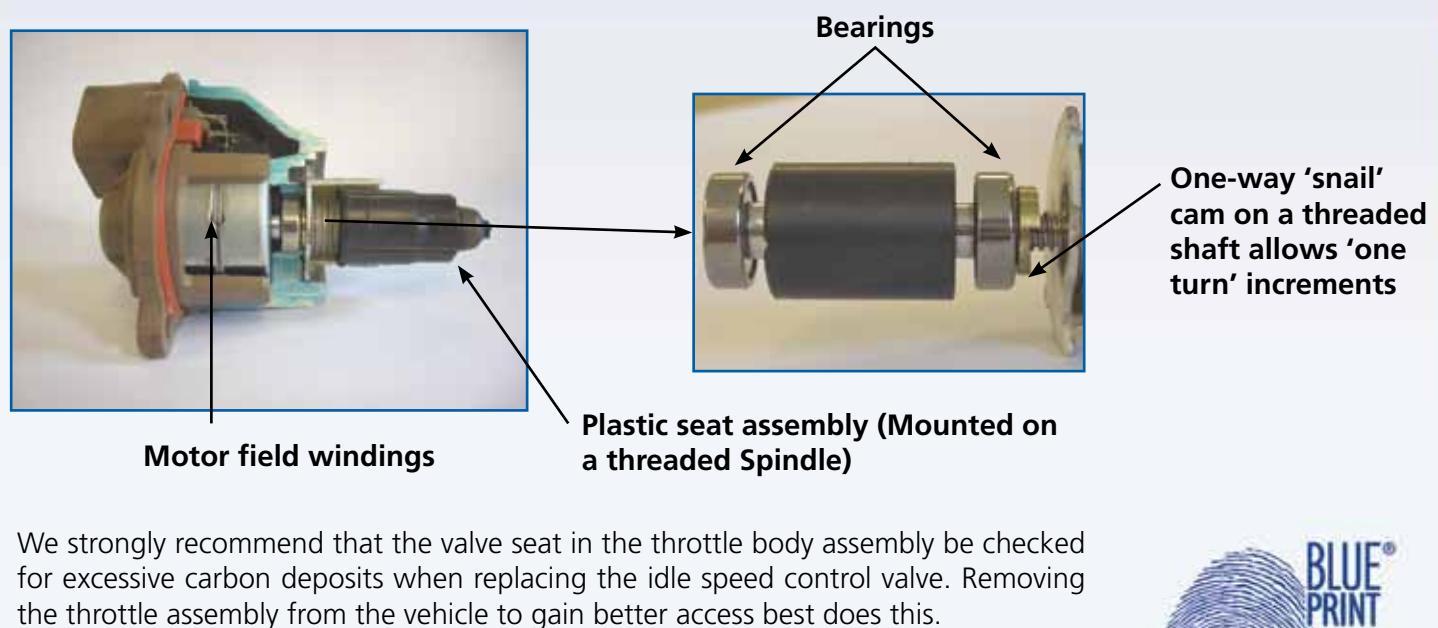
This particular valve operates in a similar way to an electric motor, but allows the plastic valve seat to be moved in or out incrementally (in steps) using signal pulses to adjust the idle speed.
