Blue Print ADBP250046

Toyota Prius ZVW30 & ZVW35 models

Cabin Filter for traction battery compartment

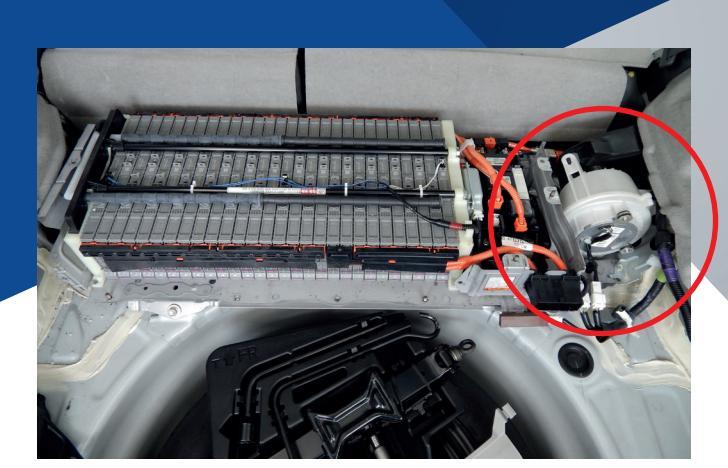
Figure 1.

The most common cause of this problem is the cooling fan becoming blocked by a build-up of dirt and dust from the interior air intake located to the right of the back seat.

The Prius models mentioned above do not have an intake air filter for the high-voltage battery cooling fan fitted as standard. Instead, the fan itself becomes the filter. The fan is located upstream of the battery and collects particulates over time. (Fig.1)

Inspect the battery cooling fan for excess debris. Take off the luggage compartment flooring and right-side trim panel to gain access to the fan module, then remove it from the vehicle and inspect.

Using a vacuum cleaner and compressed air, clear away any dust, lint or debris build-up from the hybrid battery cooling fan blades, control module and air ducts of the hybrid battery cooling system. Reinstall the hybrid battery cooling fan assembly and verify its normal operation. Repeat this procedure every 15,000 km if the vehicle is used by a lot of back-seat passengers (taxi) or is used regularly to transport pets such as cats and dogs.

It is recommended to install Blue Print filter ADBP250046, which clips over the interior air intake to reduce the build-up of dirt and dust from the interior to the cooling fan. Therefore, reducing the risk of the battery overheating and premature failure.
