Is that belt really worn out?

With advances in drive belt technology, the service life has been extended and the materials and their characteristics have changed significantly. Dayco has developed a tool to help mechanics quickly and easily determine when a belt is worn out.

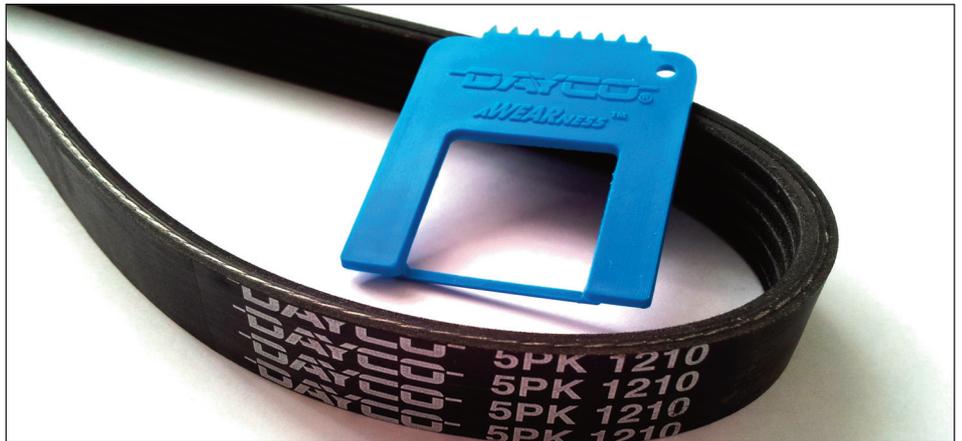
As a result, the 'V' profiles of the ribs on the belt begin to wear down and start to resemble a 'U' and not a 'V'. As the profile changes, the contact area of the belt on the pulley is reduced, and the efficiency of the belt drops. This wear can lead to slippage and affect the performance of the belt, as well as make it very noisy.

A new or serviceable belt, top, and a worn belt that needs replacement, bottom.

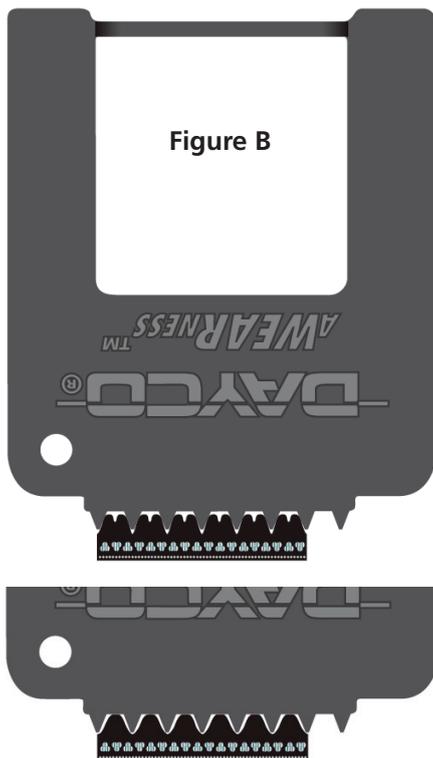
Figure B

First, the profile of the ribs can be measured using the 'comb' end of the tool which, when held against the ribs, will show whether there is any side clearance between the teeth of the 'comb' and the side of the ribs. A new (or still serviceable) belt will show no side clearance, as shown in Figure A. On a worn belt, the base of the teeth will bottom out on the top to the ribs and reveal a gap between the sides of the ribs and the teeth of the tool, as shown in Figure B.

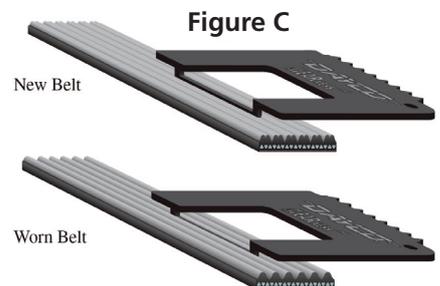
Figure C

A new or serviceable belt, on top, and a worn belt that needs replacement, on bottom.

The second check will show the wear on the ribs themselves. An indicator 'bar', on the opposite end of the tool to the comb, will sit above the tops of the ribs when placed lengthways along the groove on a new or serviceable belt. On a worn belt, the bar will sit below the top of the ribs. This shows that material has worn away and the gap between the ribs has increased. (Fig C)
