Tech Tips Eure!Car Tech Blog highlights

This new post discusses the details of a common failure in VAG TSi engines, timing chain stretch and/or loss of crank/camshaft synchronisation.

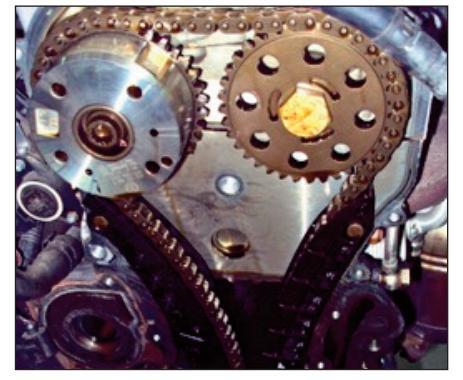
The problem may be caused by the stretching of the timing chain, or even loss of synchronisation, which it is caused by a mechanical failure of the chain tensioner.

When the engine stops, the tensioner loses oil pressure, leaving the timing chain slack at the bottom of the crankshaft. When restarting, a lack of synchronisation with the camshafts may occur.

Slack timing chain between the camshafts

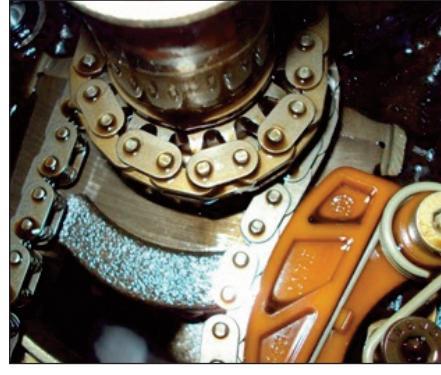
Slack timing chain at the crankshaft sprocket

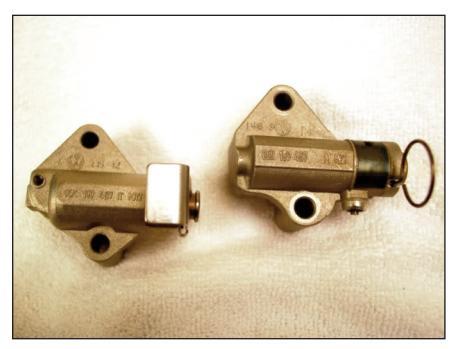
Hydraulic tensioners, the old design (on right) and modified (on left)

If the chain needs replacing, use a complete timing chain kit with a new hydraulic tensioner. Ensure that the modified model is installed. The two hydraulic tensioners are shown to the right on this page. Check for any other damage that may have occurred inside the engine. Loose or broken parts may have caused other damage that may have to be repaired.

Replace the tensioner of the timing chain every 60,000km and make sure that the modified tensioner is part of the timing chain kit.
