LuK Clutch Academy

Citroen C5 2.0 HDi (RHZ)

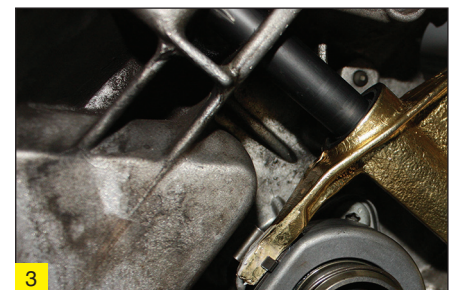
The gearbox can then be gently lowered to the floor by rotating slightly to allow it to clear the sub frame. Important to note is that the old release bearing will be attached to the pressure cover (fig4) and this is where most will go wrong as the new release bearing, prior to fitting the new clutch, will be pushed into the clutch cover. This should never be the case. The release bearing MUST be installed to the release fork first.
