SERVICE INFO

Potential problems with Concentric Slave Cylinders

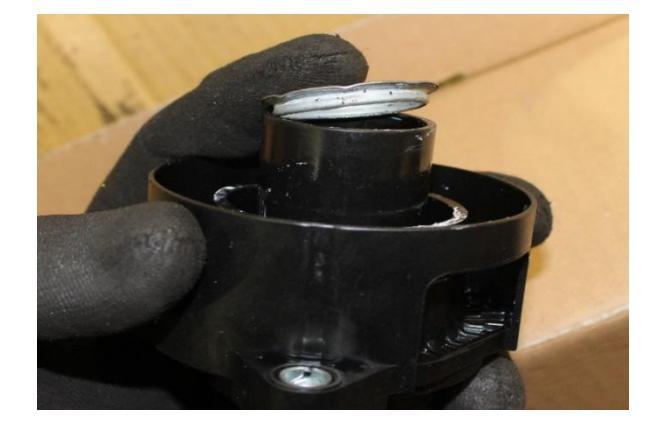
<u>Over-stoking</u>: This is when the bearing exceeds its maximum travel. This can occur if the system is rapidly bled (not allowing the CSC to return to its stop) or the pedal stop is missing. It can also be seen if the incorrect clutch is fitted causing the diaphragm to sit at the wrong height. This will cause the bearing to exceed its normal operating stroke and contact the retaining ring on the end of the guide tube. This will damage both the retaining ring on the end of the guide tube and the internal seals.

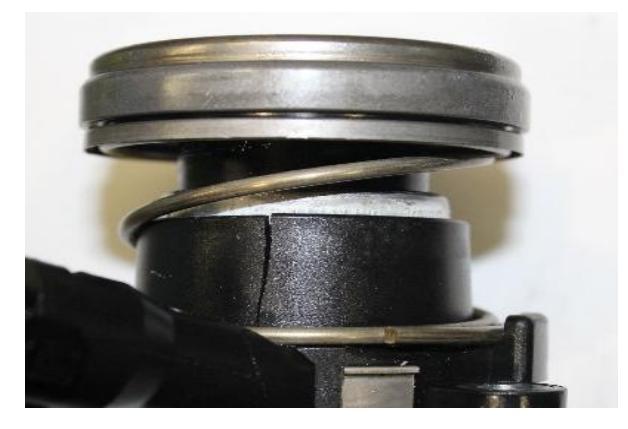
<u>Over-pressurized</u>; The pressure applied by the master cylinder is greater than the return pressure provided by the diaphragm spring. Therefore any restriction in the feed pipe (blockages, damage, incorrect routing, failed regulator valves etc.) will cause the CSC to over pressurize. Depending on the design of the CSC this can result in either the CSC over-stroking or the housing cracking. Pressure bleeding is not recommended as this can cause this condition.

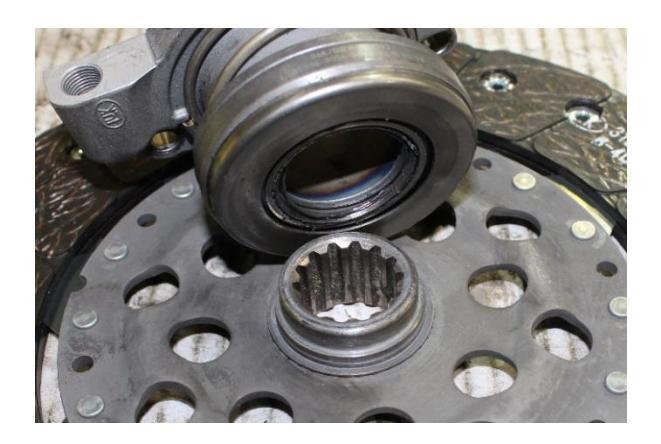
Driven plate wrong way round: On many applications the splined hub protrudes further on the flywheel side than the gearbox side. If the driven plate is fitted facing the wrong way the hub can contact the guide tube causing damage to the CSC. "Gearbox side" and "Flywheel side" translations can be found on Technical Bulletin number LuK 0025.

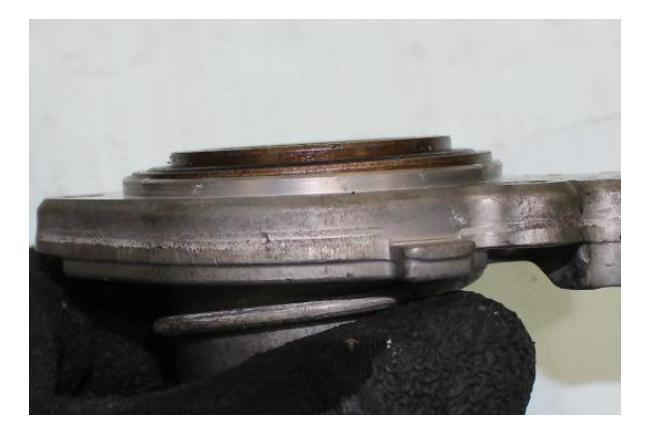
<u>Misalignment</u>; This can result in the back plate becoming unseated and can be caused by forcing the CSC onto it's mating face, often using one bolt to pull the CSC home (which can also cause damage to the retaining lugs) or accidentally striking the bearing or guide tube onto the diaphragm during gearbox positioning.

<u>Distortion</u>; Distortion of the back plate can be a result of incorrect torque, damage or contaminates on the gearbox mating face. Ensure the mating face is in good condition, free from debris and any old sealing rings are removed and replaced.
