# Turbo failure: causes and repair

Damage to the turbine is one of the primary reasons behind poor turbo performance, or even complete component failure. Mahle explains how contamination, of some form, is generally responsible, and steps to take after a failed turbo has been replaced.

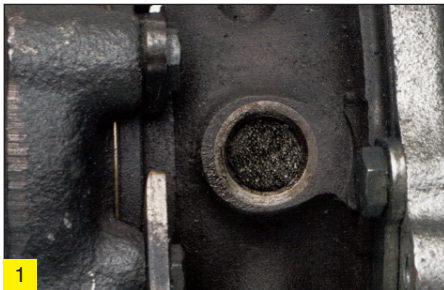
If oil carbon enters the bearing case, (Fig. 1) it can result in any or all of the following: blue smoke, loss of engine performance, loss of engine oil, contamination of the charge-air cooler, clogged exhaust gas cleaning system and with adjustable turbochargers, blocked control mechanisms.

Generally, these effects are caused by poor quality engine oil, an overheating turbo or the immediate shut down of a hot engine. Therefore it is vital to use the correct grade of oil as specified by the vehicle manufacturer (VM) and to let a hot engine run for at least a minute before shutting it down.

In addition, mechanics must thoroughly clean the oil pan, and flush the oil following turbocharger damage to ensure that no foreign deposits enter the lubrication circuit. Mechanics must also pay close attention to the necessary installation instructions and performance measures during engine tuning.

Naturally, observing the VM's oil change intervals and replacing the filter with an OE replacement is a prerequisite.

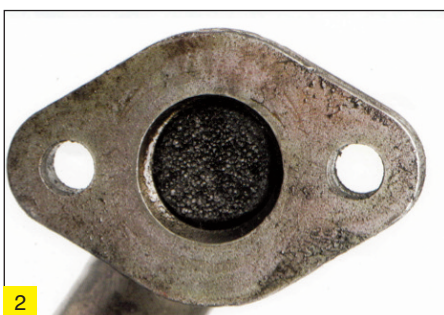
Oil carbon deposits in the oil pipe (Fig. 2) can have similar effects to oil carbon in the bearing case, but can also lead to excessive turbocharger noise, and even total turbocharger failure.

Additional causes include an overdue oil change, incorrectly installed oil pipe or a missing heat shield. Subsequent additional remedies include replacing the oil pipe and ensuring its correct installation and replacing the charge-air cooler and particulate filter if the turbocharger has been replaced.

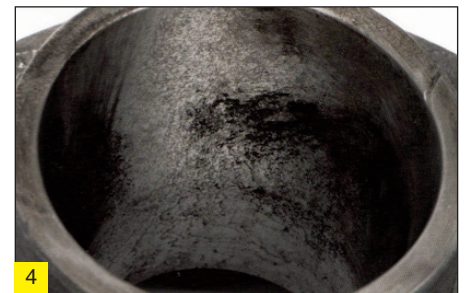
When it comes to the air intake side of the equation, contamination of, or stress to, the compressor wheel or compressor itself will result in blue smoke (or black in the case of stress marks on the compressor wheel), excessive noise or whistling and contamination inside the charge-air cooler.

The causes can vary, but can include contamination entering the system from the

crankcase vent (Fig. 4), a build up of ice or even a leak in the system from, for example, a split turbo hose.

When it comes to the compressor wheel, stress is generally caused by dirty or an insufficient oil supply to the bearing, an increase in exhaust back pressure or a clogged air filter.

To remedy these situations, mechanics must carefully clean the entire intake system, replace the air filter with an OE replacement, clean or renew the crankcase vent and check the system for leaks. In addition, if fitted, the air compressor's cylinder head must be dismantled and cleaned. Also following the replacement of the turbocharger and charge-air cooler, the mass air flow sensor must be checked.

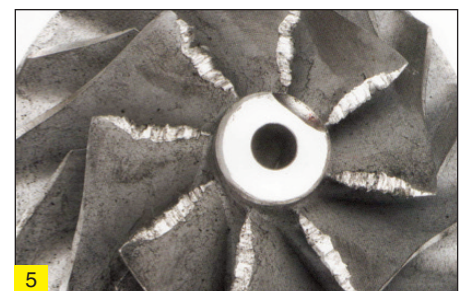
If the compressor wheel bearing is damaged (Fig. 5), its clearance on the rotor shaft must be checked, the engine oil flushed, a new OE filter fitted and refilled with the correct grade of engine oil, as specified by the VM.
