Replacing squeaky Tesla Control Arms

Tesla drivers all over the world reported annoying squeaking sounds in Model 3 and Model Y vehicles, so MEYLE engineers analysed the problem. After intensive development work, MEYLE HD designed an improved control arm for these models, which is now available to the aftermarket. These instructions will guide you through the entire job.

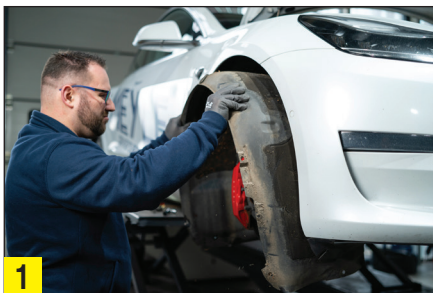
Step 1: Remove the wheel and inner wheel arch. Remove all clips and the screws located under the wing.

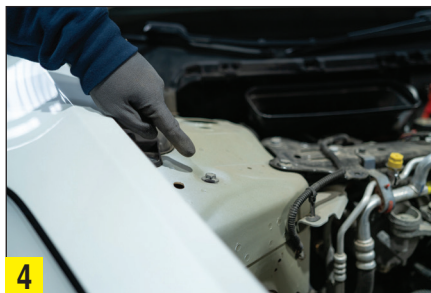
Step 4: Remove control arm top mount fixings, located in the frunk. The drain that allowed water to contaminate the original control arm is next to the mounts.

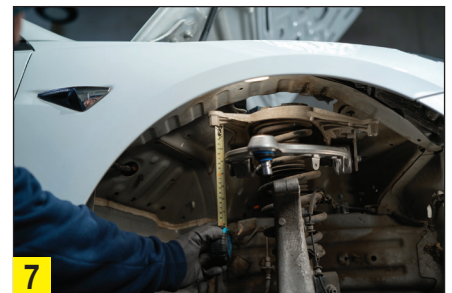
Step 7: Push the ball joint in the swivel bearing

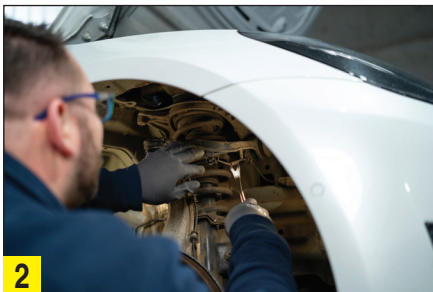
Step 2: Check all the other suspension parts for damage and general condition. Release the ABS wire where it is attached the control arm.

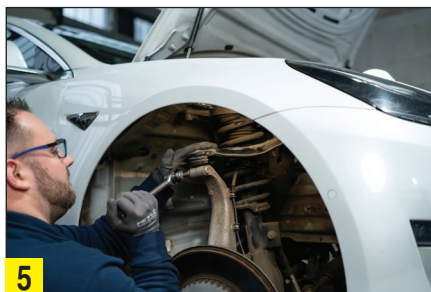
Step 5: Remove ball joint and control arm fixings. Pull the control arm out of the top mount.

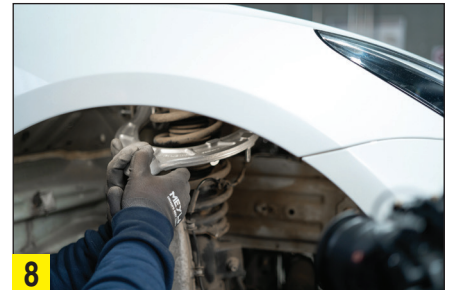
Step 8: Tighten all fixings to manufacturer recommended settings:

- Ball joint screw – 56Nm
- Bearing control arm – 50Nm
- Top mount 13mm screw – 35Nm
- Top mount 15mm screw – 62Nm

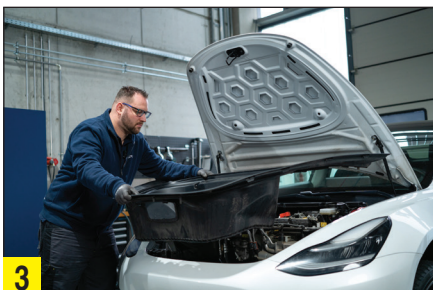
Step 3: Remove the frunk, by first removing the circuit breaker, and then the screws and clips.

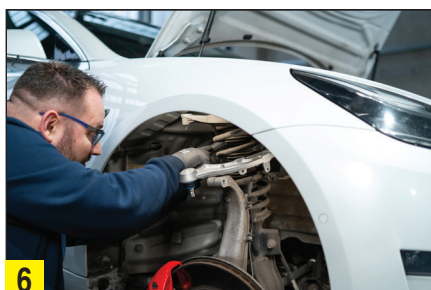
Step 6: Push the new MEYLE HD control arm into the top mount. Adjustment between the arm and the top mount should be 60mm.

Re-attach the ABS cable to the control arm.
