# Common turbo problems

## REA/SREA failure modes

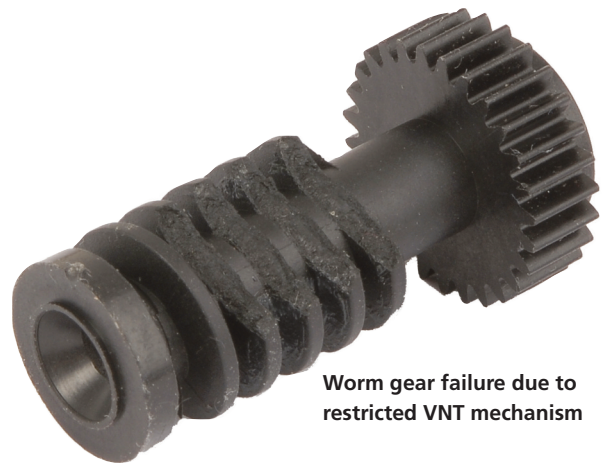
• **Gearbox Failure** - REA and SREA will fail, as a result of the variable geometry mechanism sticking due to sludging or carbon build up within the turbo. When the variable geometry mechanism sticks, it pulls a higher current through the motor than it is designed to take, causing the motor or the plastic worm gears to fail. This restriction can reduce boost pressure and can result in the vehicle being put into 'limp home mode'. In most failures, the black cap and electronics are unaffected by the gearbox failure and can be reused.

**Worm gear failure due to restricted VNT mechanism**

- When repairing the electronic actuator, the worm gear and motor must be the correct ratio to avoid immediate failure.
- REA actuators must be calibrated to the turbo after repair. Incorrect calibration of the electronic actuator when assembled on the turbocharger can result in poor performance.
- Soldering to repair broken connections in the gearbox and black cap is not advised. Solder is susceptible to cracking in environments with temperature variance and vibration. For this reason, the motor and motor choke assembly connector must be spot welded.

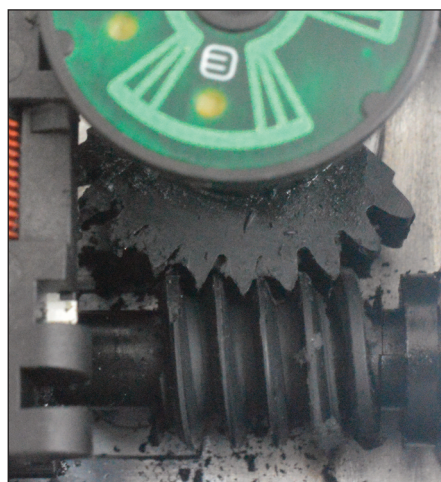
**CIPOS gear, worm gear and motor failure. A complete gearbox is required with failures of this nature.**
