Previous Technical Bulletins

CL 045 Fitment of friction plate in kit 826033

Vehicles: Citroen - Berlingo, C3, C5, Dispatch, Relay, Xsara Fiat - Ducato, Scudo

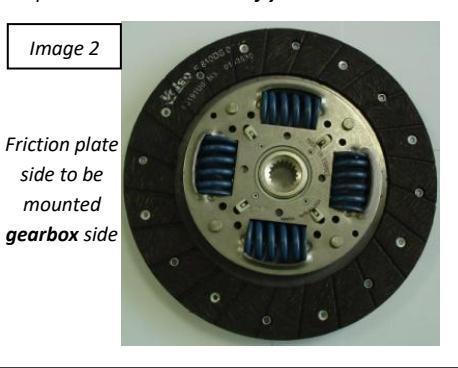
826033 drive plate has a different type of layout on each side. Image 1 showing a large central hub raised away from the friction material, and image 2 showing a flatter side on the hub.

Friction plate side to be mounted flywheel side

Image 2 should be mounted to face the gearbox and sit against the cover, whereas image 1 should be

facing the flywheel with the raise spline hub fitting centrally when mounted.

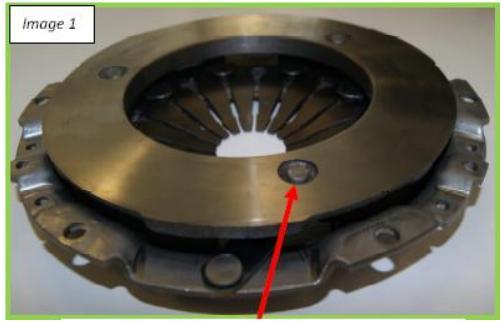
Valeo Technical Support and the Warranty Claims Department are receiving a number of calls concerning the concept / design of clutch kit 826633. Specifically, concerns are being raised due to the unusual position of the rivets which are recessed into the pressure plate surface area. The rivets are situated beneath the friction surface area of the cover and will not affect the performance of the clutch.

Recessed rivets (below surface area) on pressure plate

Please note this is a unique design and will not affect the performance of the clutch.
