An electronically shifted 5-speed overdrive automatic transmission that has been around since 1996. It has been used by a number of vehicle manufacturers and can be found in a variety of Mercedes, Chrysler, Jaguar, Jeep, Dodge and Ssangyong models.

Problems relating to gear change and selection can be due to the failure of the contacts in the conductor plate which carry the electrical sensing and control solenoids for the transmission. (two speed sensors and six solenoids, located on top of the valve body in the transmission), causing faulty signals and resulting in the engine management light (EML) illuminating and the vehicle going into 'limp-home' mode.

Replacing the Conductor Plate

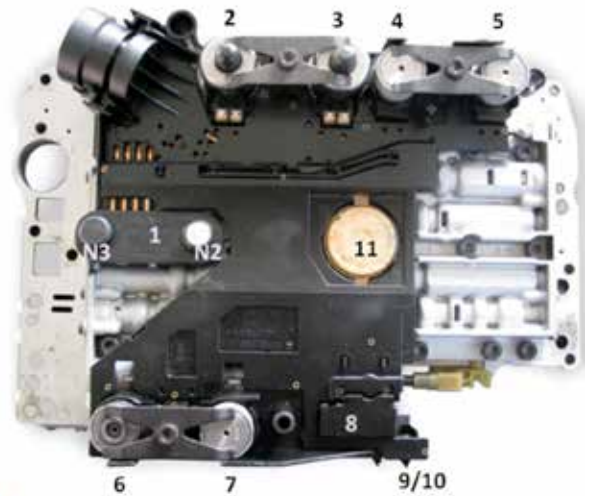
An assembled conductor plate layout and components:

1. N2 and N3 are two Hall Effect speed sensors, monitoring the speed of two separate rotating members and providing input shaft speed.
2. Line pressure modulating solenoid, controlled by pulse width modulation (PWM) on the earth side.

3. Shift pressure modulating solenoid, controlled by pulse width modulation (PWM) on the earth side.
4. 1-2/4-5 12v gear shift solenoids, which are earth switched by the TCM.

5. 3-4 12v gear shift solenoid, which is earth switched by the TCM.
6. Torque converter lock-up clutch pressure control solenoid, controlled by pulse width modulation (PWM) on the earth side.

7. 2-3 12v gear shift solenoid, which is earth switched by the TCM.
8. Reed switch, closed by a magnet in a plunger and moved by the selector. The reed switch is in series with the temperature sensor for the purpose of indicating the Park and Neutral positions to inhibit the starting of the vehicle with a gear engaged.

9. PTC temperature sensor thermistor, providing transmission oil temperature.
10. Transmission fluid level sensor
11. Float-ATF expansion plug

- Work on a clean prepared surface.
- Remove the plastic solenoid covers from the valve body conductor plate (if fitted) and then remove the 3 torx bolts that secure the springs that retain the solenoids.
- The solenoids can now be carefully removed. Ensure that you note the position of each solenoid so that they are fitted to the new conductor plate in exactly the same positions.
- The shift solenoids do not have O-rings, whilst the pressure modulating solenoids have two.
- Remove the conductor plate from the valve body.
- Inspect the O-rings and the ports into which they fit and inspect the port filters for debris.
- Check the resistance of the solenoids (see Conductor plate terminal diagrams) and inspect for corrosion.

- Position the new conductor plate onto the valve body.
- There are two locating tabs that will snap into position.
- Lubricate the O-rings and push the solenoids into their correct ports while aligning the contacts.
- Refit the solenoid retaining springs and torx bolts and tighten to 8Nm.
- Refit the plastic solenoid covers
- Wipe the mating surfaces between the valve body and transmission with a clean lint-free cloth and refit the valve body locating the selector plunger on the selector sector.
- Tighten the valve body retaining bolts to 8Nm.
- Lubricate the new strainer O-ring and fit the new oil strainer. Be sure the barbs on the strainer fit into the slot in the valve body.
- Lubricate and fit the new sump pan gasket and fit the

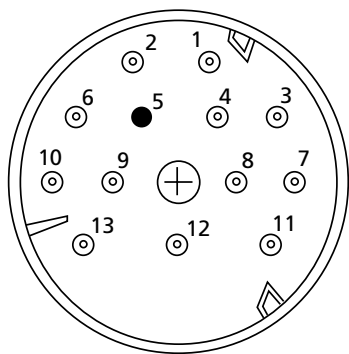
Conductor Plate Terminal

Conductor plate terminals	Component	Value
1	RPM signal N3	Square wave (2nd gear)
2 and 6	Line pressure modulating solenoid	5.5Ω
3	RPM signal N2	Square wave ('P' position)
4 and 12	ATF Temp sensor/inhibitor	800-1200Ω at 20°C in 'D' or 'R'
5 not used	Not used	Not used
6	Solenoid voltage supply	Battery voltage
7	RPM Sensor voltage supply	4-8 Volts
8 and 6	2-3 shift solenoid	4.5 Ω
9	3-4 shift solenoid	4.5Ω
10 and 6	Shift pressure modulating solenoid	5.5Ω
11 and 6	Lock up clutch modulating solenoid	2.7Ω
12	Sensor ground	0.01 volts or less
13	1-2/4-5 shift solenoid	4.5Ω

Further checking of the conductor plate components can also be carried out at the conductor plate terminal, while either disconnected or back-probed whilst connected. This can also be done at the TCM with appropriate TCM terminal pin data.

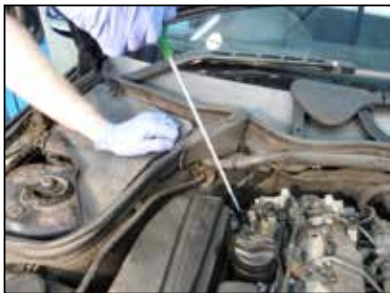
Check the Automatic transmission level

Remove the red locking tab on the transmission filler tube and remove the plug. The dipstick is around one metre long and is pushed into the transmission dipstick tube until it touches the bottom of the sump pan. There will still be some of the dipstick sticking out of the filler tube.

The transmission fluid has a very high rate of volumetric thermal expansion so there are two marks on the dipstick - a lower mark for measuring at 25°C and a higher mark for measuring at 80°C. With the engine warm use the scan tool to check the transmission temperature. The transmission must be in 'D' or 'R' to close the reed switch in the transmission fluid temperature sensor. In other positions the value defaults to coolant temperature.

Take a measurement with the engine at idle and the fluid temperature at 80°C

Very few 722.6 applications are fitted with an ATF fluid level dipstick. The dipstick is available from febi – part number 38023.

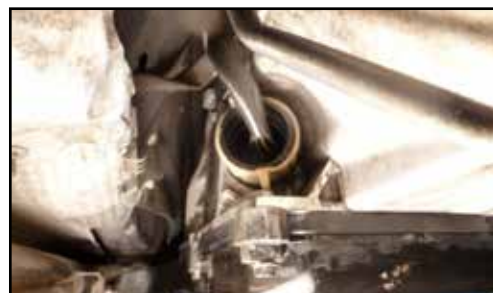
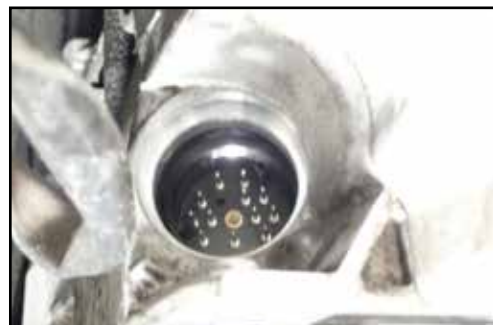
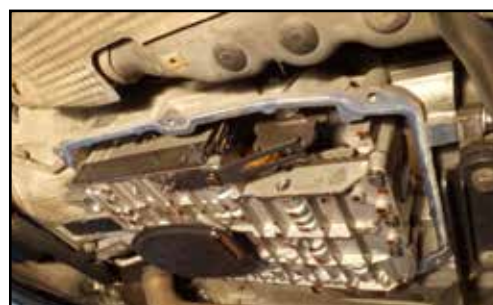
Removal of the Conductor Plate

- First drain the Automatic Transmission Fluid (ATF) into a clean receptacle which is best done with the transmission warm.
- Measure the quantity and check the fluid for condition and debris.

- Further dismantling is best done once the transmission has cooled to ambient temperature.
- Remove the cover on the harness plug.
- Turn the lug on the tan collar anticlockwise - it will click and then jack-out the 13 pin harness plug.

- In the centre of the plug is a 7mm bolt. Undo the bolt and then prise out the guide sleeve.
- Note: The guide sleeve seals are a common source of transmission oil leaks. The febi sleeve includes new seals.

- Refit the sump drain plug.
- Support the sump pan, undo the 6 torx bolts and sprags (spacers) and lower the sump pan into a drain receptacle.
- Note: There will still be fluid in the sump pan and fluid draining from the transmission. There is likely to be a fine dark grey film in the sump pan which is perfectly normal.

- Inspect the sump magnet for metal pieces indicating more serious mechanical damage.
- Clean the sump pan and magnet.
- Remove the oil strainer.
- Identify and remove the 10 torx screws holding the valve body to the transmission.

- Be warned that the valve body is reasonably heavy.
- Remove the valve body, paying close attention to the inhibitor plunger.
- Inspect the drained transmission fluid. Darkening of the ATF and the smell of burning may indicate heavy clutch wear/slip.
