Understanding and stopping brake judder

Brake judder manifests itself in vibrations that can be felt through the steering wheel, the pedals and potentially through the seat. Depending on the severity, a vehicle's chassis may even start to pulsate. Apec explains the source of judder, and how to reduce the possibility of it occurring.

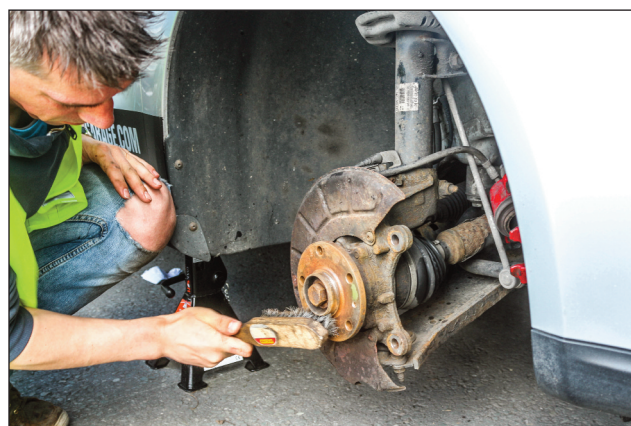
Remove all of the contact and surface rust from the hub

One of the major causes of DTV is lateral run-out caused by improper cleaning of the hub surface. Similar to the butterfly effect, even the most minute particles of rust caught between the disc face and hub, (measuring as small as 0.04mm), can lead to lateral run out (where the turning disc starts to deviate from its axis) in excess of 0.1mm when measured at the centre of the braking surface. The important point to note is that while this deviation may not immediately induce brake judder, it has provided the foundations for a vibration that will eventually lead to it, and

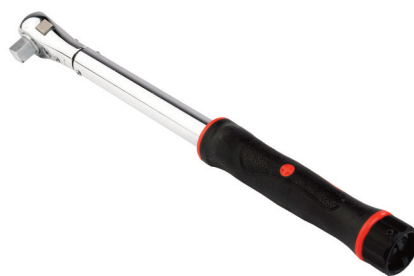
A torque wrench should be used for the final tightening of a wheel nut or bolt

wheels, that bolts are checked and in serviceable condition. Check the condition of the bolts thread as well as the bolts integrity. Never use fasteners that are suspect. Make sure all threaded locations are clean and free of dirt, grime or other contaminants as poor quality or unclean threads can result in incorrect torque readings. Never use an air gun to fully tighten a wheel nut or bolt, this could distort an alloy wheel. The final tightening should be done with a torque wrench in the correct sequence.
