Audi A4 - Heavy fuel consumption

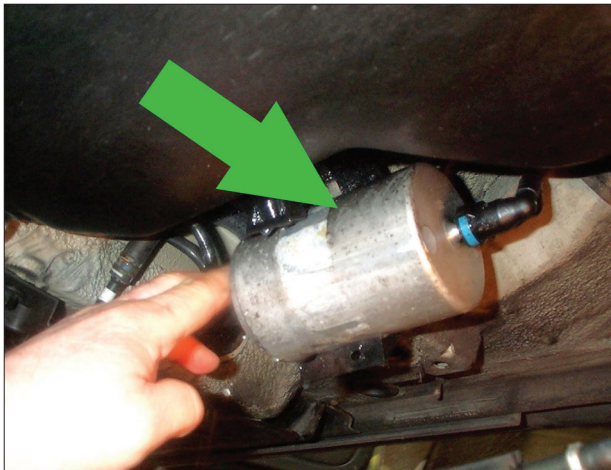
The fuel filter had a tiny pin hole under the securing bracket

a tiny pin hole in the fuel filter, which was allowing the fuel to seep out.

Amazingly, the petrol filter on the A4 does not appear to have a designated service interval, but as this one proves, it does need changing occasionally.
