## SEAT Ibiza - Too late for any service

## FORD FOCUS - Power steering pipe problem

## Audi A5 - Problem door handle

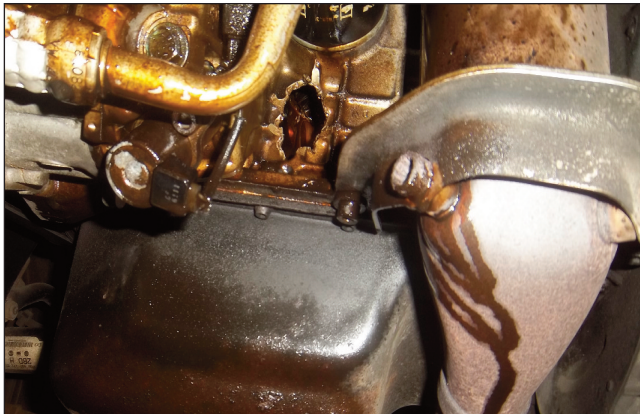
**The hole in the side of the engine block was a result of years of neglect, and insufficient oil changes**

When the vehicle arrived, it didn't take too long to discover the problem was terminal. The lack of oil changes had taken its toll and now the con rod had pushed its way out through the engine block.

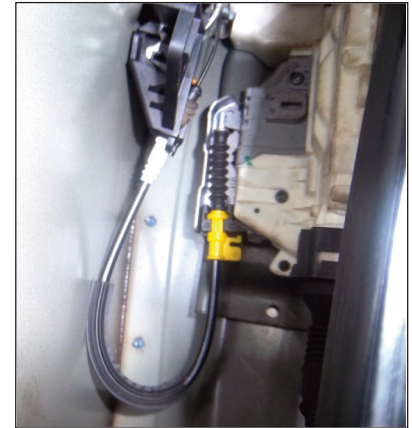
**With the door panel removed the connecting cable could be seen to be ok, the problem was the lock itself**

Once we had removed the door panel, we found that this was operating perfectly. The cause of concern on the Audi was the lock solenoid unit itself.
