# BMW X5 - Brake pipe corrosion

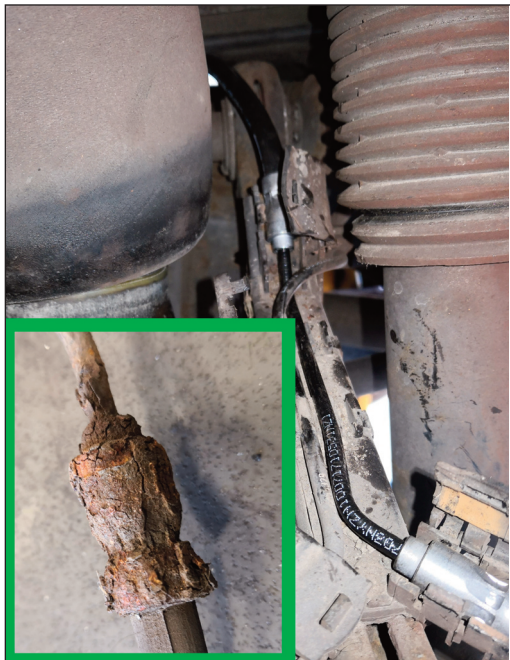
Unfortunately, the BMW had still been sitting out on the road during the lock down period and so this had not prevented the rust from doing its worst. Before this X5 could get its new NCT certificate, it was going to need a couple of brake hoses at the front. The metal ferrules clamping the hose onto the union had rusted, and could fail allowing for the sudden loss of brake pressure.

**The BMW hadn't travelled far but that didn't stop the corrosion from getting into the brake pipes**
