Calliper Slide Seized and not Shifting

Ford Galaxy - Topping up the Brake Reservoir

Land Rover Discovery - Bulging Tyre

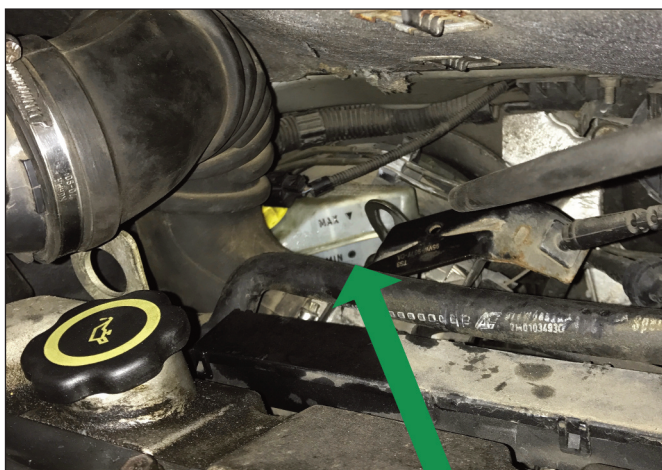
Not so on this Galaxy. The reservoir and master cylinder are hidden deep at the back of the engine bay, below the scuttle panel. Having come across this before, we have fashioned a small piece of aluminium trough to guide the fluid along to the reservoir and enabling us to top up without too much fuss.

The brake master cylinder and reservoir are hiding deep in the engine bay, making topping up very difficult

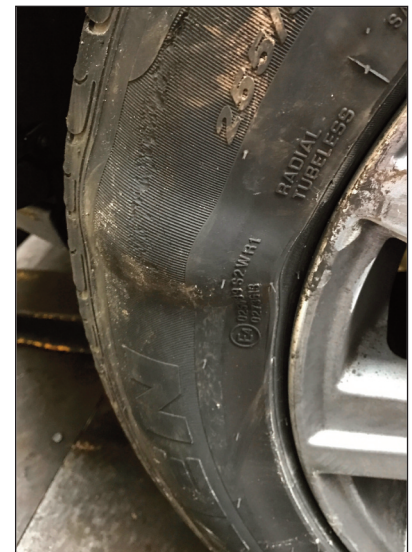
The bulge in the tyre made it unfit for purpose even though it was less than a month old

Insisting that the tyre did not need replacing, I had to inform him that I did not agree. At that point I also let him know that the cause of the failure was his continual bumping up and down kerbs.
