Chevrolet Lacetti - Bad brake wear

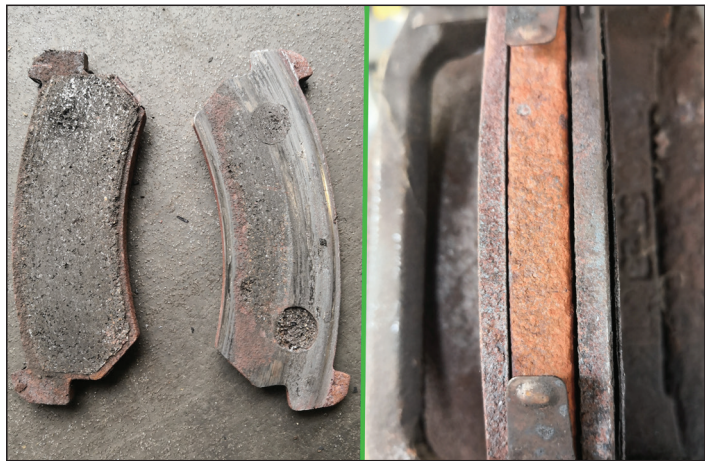
The offside front brake caliper had seized and caused the brake pads, which she had

not looked at, to wear down at an accelerated rate. The brake lining was worn completely, and the backing metal of the brake pads were touching the brake disc. The Chevrolet needed not only a new brake caliper, but also a new brake disc and pads before it was safe to use again.

By only checking the nearside, the offside wear had gone unnoticed
