FIAT Punto - Coolant temperature sensor

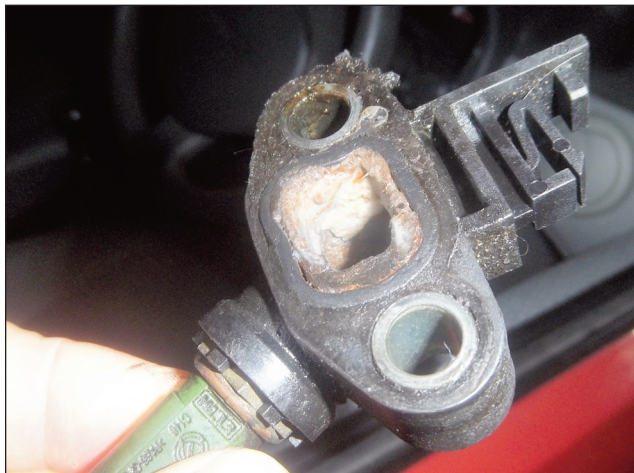
The leak was from the small outlet which also houses the coolant temperature sensor

Eventually, I tracked the leak down to the water outlet at the back of the cylinder head next to the inlet manifold. The problem was not to be too serious. The small outlet which holds the temperature sensor comes complete with a new sensor. Although it is only held in place with two bolts, it is clipped into the end of the inlet manifold, meaning it must come out at the correct angle.

Once the job was completed the cooling system was bled out and the Punto was active again.
