Rover Group Mini 1.3injection

CLTB 0016

THE IMPORTANCE OF FITTING THE CORRECT CLUTCH KIT HK6604 TO MINI 1.3injection models.

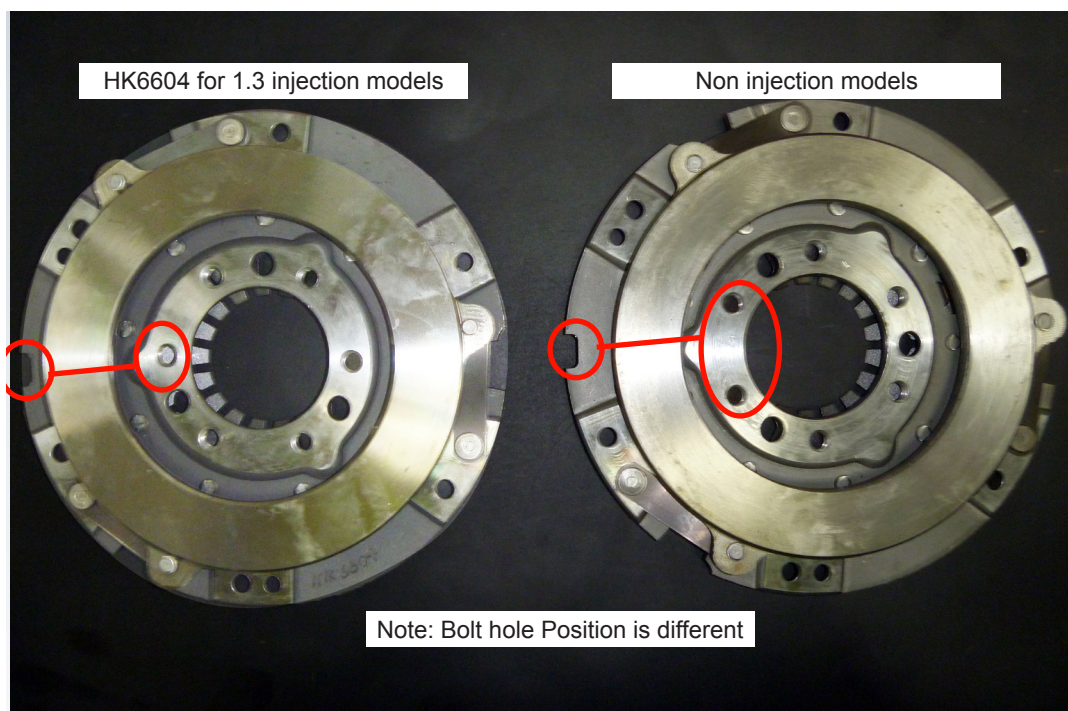
Concerns; We have had several instances now where the incorrect clutch cover/clutch kit assembly has been fitted to the 1.3i Mini. The incorrect kit part numbers being HK8150 and HK9064. Although the clutch covers look very similar to the one in HK6604 there are subtle differences with the drillings and tapped holes in the central hub mounting face, which then controls the position of the timing ring when the flywheel is fitted. If the wrong one is fitted, the car will be difficult to start and does not run correctly.

Method; The differences on the drilling patterns are indicated below. Please ensure the correct type of cover/clutch kit is fitted.
