Ford Focus - Bonnet release trouble

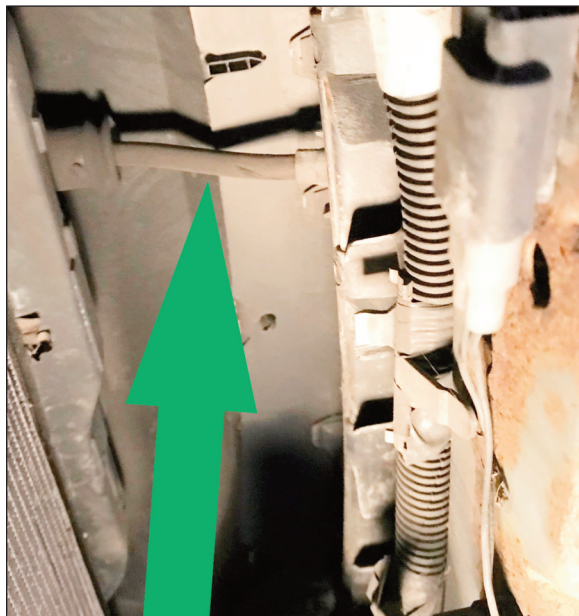
The problem with the bonnet release system on the Focus is that the key operated cable which travels back to the lock can stretch and not turn the catch enough to release it. Another common failure is a small plastic clip in the end of the cable that can also fail and stop the bonnet from opening. I have seen a few different methods of releasing the bonnet under these circumstances, but they all result in a new catch and cable being needed, so before I started I ordered up the new parts.

After removing the under shield and accessing the outer cable it can be gripped tightly and then turning it may often release the bonnet, however a new cable will be required

In the case of this Focus, I was able to grab the outer cable of the release mechanism after removing the lower shield, by going up from underneath, and in front of the radiator. Once the cable was firmly grasped in a pair of grips I twisted it, which in turn twisted the mechanism sufficiently to pop the bonnet. Of course, once the bonnet is opened the grill can be removed and access from there on is easy.
