Ford Focus steaming once in awhile

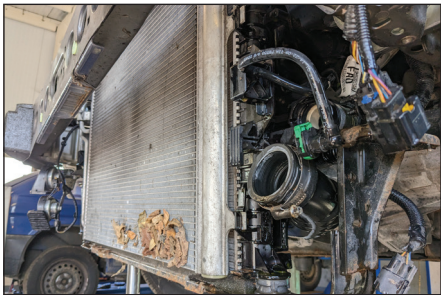
Removing the front makes this job easier

The manual gives the instructions that the radiator should drop down from underneath once the supporting bracket has been removed, but due to sticking hoses and corroded fixings, it can often be easier and quicker to remove the front of the vehicle to give clear access to the radiator pipes and fixings.

With the front removed, the radiator could be replaced and it is much easier to locate the top fixings when they can be seen.
