KA engine falling

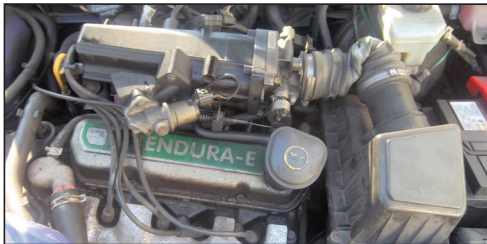
The gearbox mount had broken allowing the engine to drop down

A quick look revealed the gearbox mounting bracket had failed and allowed the gearbox, along with the back end of the engine to drop around 6 inches. Once fitted the bargain basement motor was back up and running again.
