Ford Ka only getting hot on one side

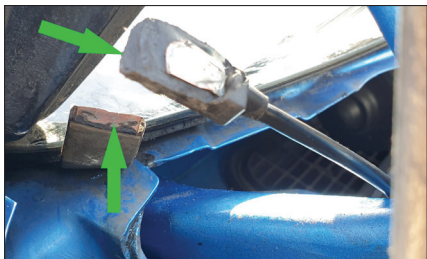
The connection on the terminal is quite a common failure

I explained that the problem may be the circuit in the screen itself, in which case the only remedy would be for a new screen, but I would have a look. Upon inspection, the problem was found to be the connection between the wiring and the terminal on the screen, this had corroded and broken away.

It took a little gentle cleaning and careful repair work to reinstate the driver's side of the screen, which then, much to the delight of the owner, became operational again.
