# Ford Mondeo flywheel replacement

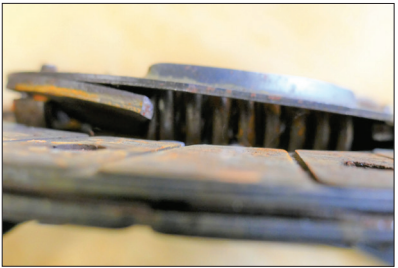
**The friction plate had ripped away from the centre spline, allowing it to spin freely**

While far from home, the Mondeo had suddenly lost drive. When recovered to my workshop, the gearbox was removed to reveal that the friction plate had ripped away from the centre spline to allow the centre to spin freely, causing the loss of drive.

The problem now was matching up the failed clutch to the correct part number. This Mondeo had no details and the clutch centre could not be contacted to confirm what was needed. Thankfully the local factors could match up the clutch and the owner was sent off with the failed centre plate, hoping he would get reimbursed by the garage who fitted it originally.
