# MAZDA 3 - Heater Panel Problems

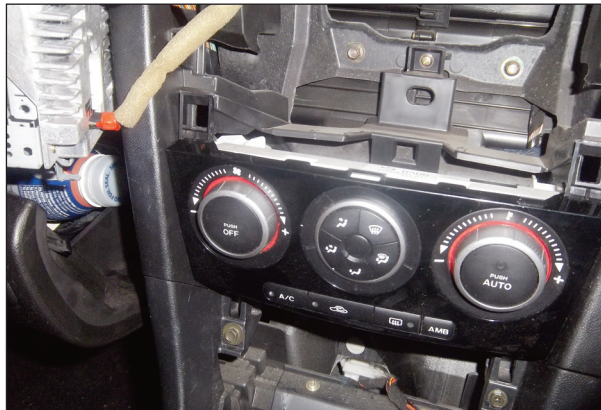
**The radio and lower trim panel require removal, to access the fittings for the control unit**

Sourcing a second-hand unit, much more reasonable at €45, and then fitting it into the centre consul proved a more cost-effective solution. This involved the removal of the radio and the lower trim to access the retaining screws.
