Mazda2 - Boot button

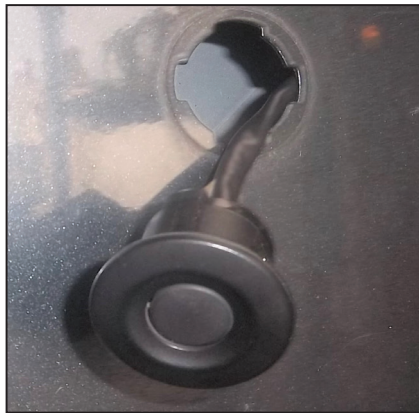
This 2014 Mazda2 has only an electronic solenoid to operate the rear hatch opening. After returning home with a boot full of shopping, the owner realised that she couldn't open the boot. In a panic, she drove along to see me, worried that the frozen food in the boot would defrost. I realised that if the release button was pushed in a certain way, and slightly to the side, then the boot latch would spring open.

Failure of the boot operating button is easily fixed by replacing the button

The owner quickly transferred her shopping into the passenger seat and popped back home to unload, whilst I ordered up the new release button for a future repair, which has become quite a common failure point.
