Mercedes SL500 - Intermittent Indicator Bulb

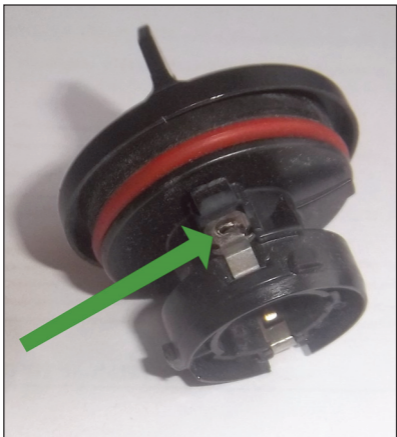
The contact point on the bulb holder had burnt through due to a poor contact

Replacing the blown side light bulb rectified the problem at the rear, but the front indicator bulb appeared to be in good order. When tested, we discovered it was in perfect working order. The problem here was the bulb holder itself, which had a burnt contact point. Wiggling the bulb holder in the lamp would temporarily restore the indicator operation. This was not satisfactory and a new bulb holder was ordered and fitted.
