MGB GT - Old style clutch job

We still see a few classics in the workshop, and this 1976 MGB GT, which had covered just over 90,000 miles in its lifetime, was one of them. It was now used only on the sunniest of days. The owner had decided that it would be good idea during the winter months, when the motor was not going to be used, to get the clutch replaced.

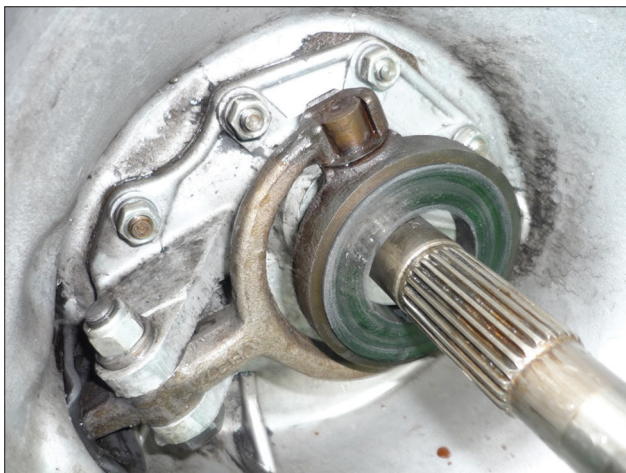
The carbon thrust release bearing had worn down

I could see that the carbon thrust bearing was well worn and would not have gone on too much longer without problems.

With the new clutch fitted and lined up, the job of sliding the engine back into position went smoothly, and the MGB was soon back out of the workshop and into its winter storage garage.
